**HØJTEMPERATURKORROSION I DANSKE
KRAFTVÆRKER**

**CORROSION AND MATERIALS PERFORMANCE IN BIOMASS FIRED
AND CO-FIRED POWER PLANTS**

Abstract

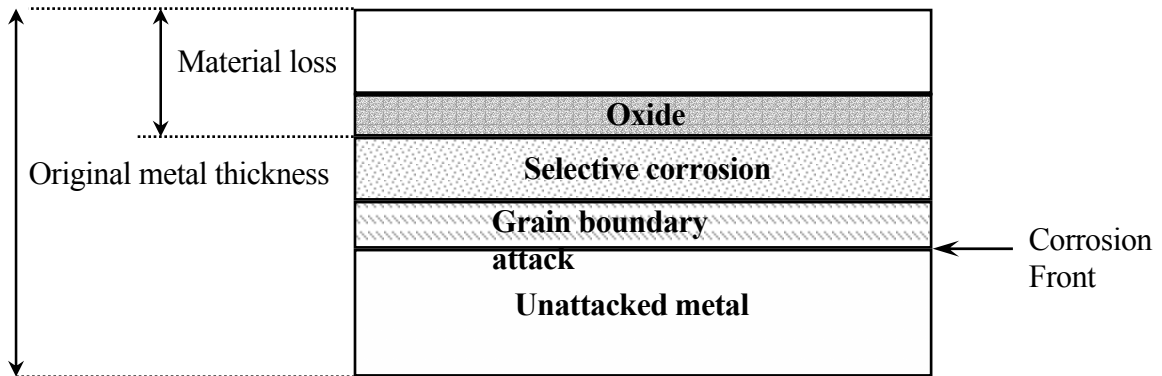
Figure 1: Schematic of corrosion attack in straw fired plants.

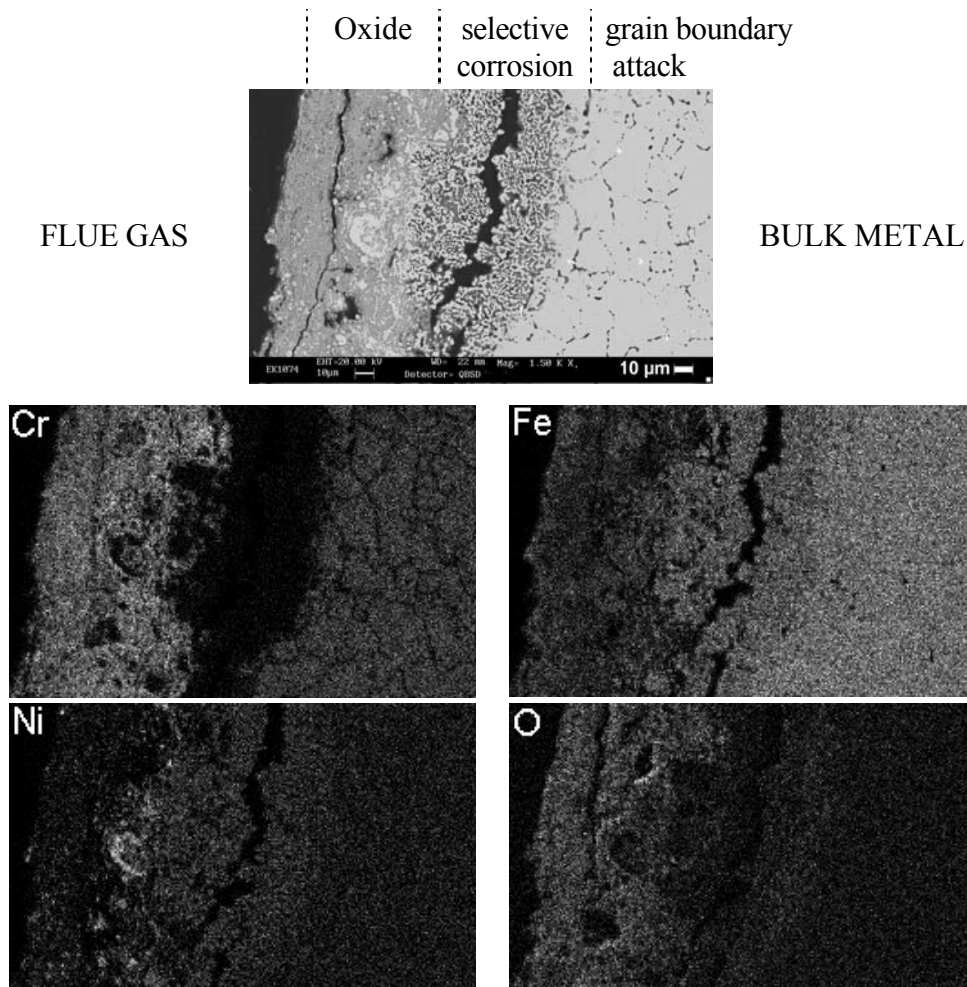
Figure 2: TP347H FG exposed for 3500 hours at Masnedø: calculated metal temperature 613°C.

Selective removal of chromium (where the metal becomes porous) and grain boundary attack is observed, such that the sum of the internal corrosion attack can be over ½ mm. For austenitic steels, grain-boundary corrosion is a precursor to corrosion within the grains. The corrosion products formed are chromium oxides and iron oxides; these are present at the surface of the specimen. In many cases, nickel is also present in the outer corrosion product as non-reacted nickel. If chlorine is detected, it is close to or at the corrosion front. No potassium is detected in this area. Even at metal temperatures lower than 500°C, chlorine containing corrosion products are still found at the corrosion front [5].

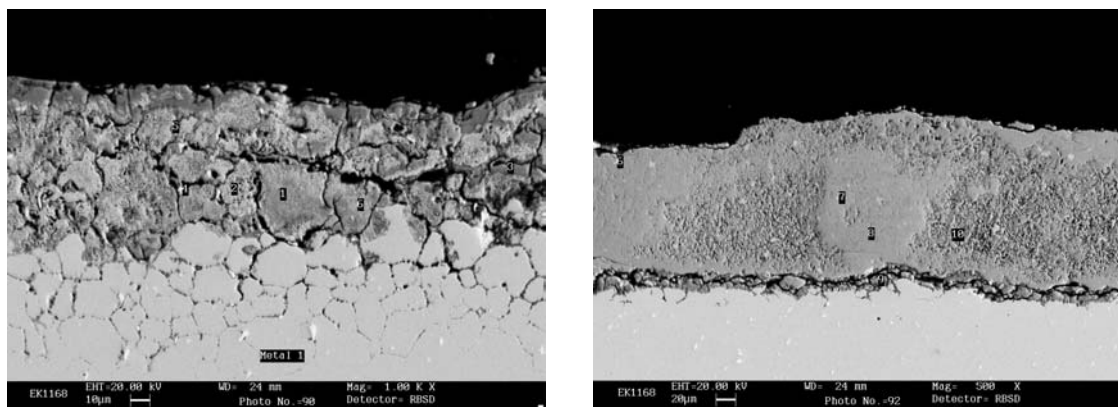
For the austenitic steels, a gradual change in the corrosion product morphology as a function of temperature is observed. A protective oxide is formed at lower surface metal temperatures below 500°C. At around 500-520°C, both grain boundary attack and protective oxides can be observed for the same specimen, as is shown for Esshete 1250. This indicates that at this temperature region, there is a transition in the type of corrosion attack (Figure 3).

Figure 3: Two areas of the same specimen for Esshete 1250 exposed at Masnedø for 8700 h (calculated metal temperature 513°C).

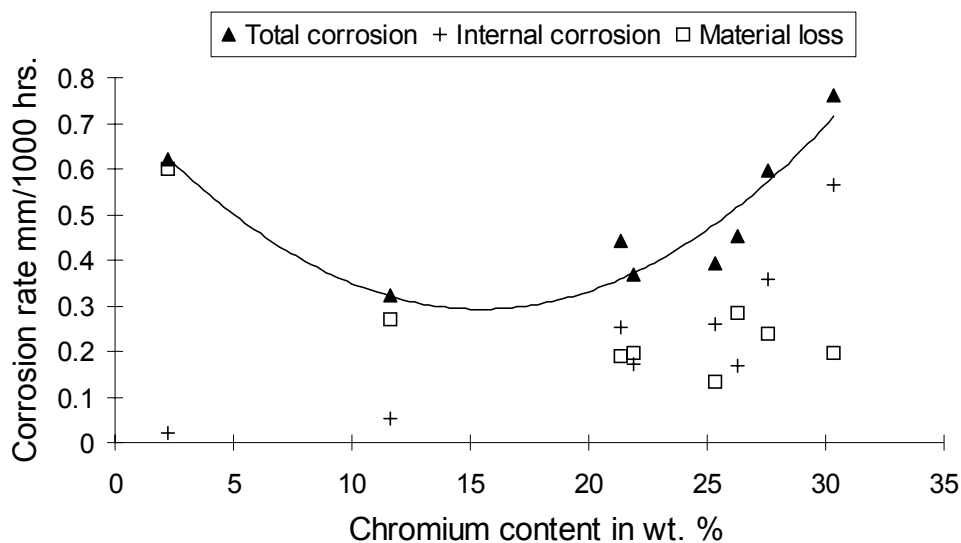
Figure 4: Corrosion rates for steels with various chromium content exposed in a probe at Masnedø straw-fired CHP Plant (approx. 550°C).

The graph shows total corrosion rate with respect to chromium percent, and also the contribution of internal corrosion (selective corrosion + grain boundary attack) and material loss to the corrosion rate. The low chromium steels exhibit a high material loss whereas the higher chromium steels are characterised by severe internal corrosion. These results indicate a minimum in total corrosion rate of steels at an intermediate chromium content of 15-18% Cr.

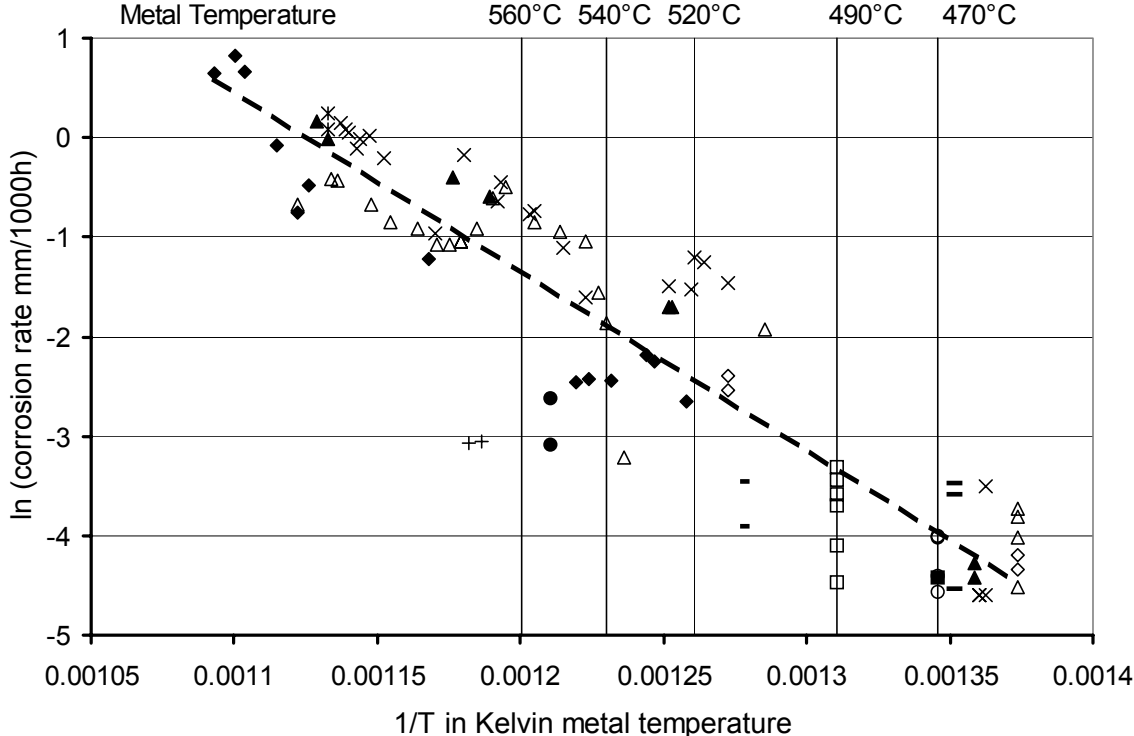
In Figure 5, corrosion rates for TP347H (both fine and coarse-grained) from the four straw-fired plants are collated. Both fine-grained and coarse-grained TP347H steels have similar corrosion rates. The results are illustrated on an Arrhenius type plot, with natural log of corrosion rate in mm/1000h on the y-axis and metal temperature as 1/T in Kelvin on the x-axis.

Figure 5: An Arrhenius type plot of corrosion rates for TP347H in straw-fired plants.

For test tubes in existing superheaters, the metal surface temperature is taken to be steam temperature plus 20°C, if more accurate data cannot be obtained. The corrosion rates from the four straw-fired power plants show a general agreement in results. The best-fit linear correlation has been inserted. However, there is a great spread in the results; the reasons for this are currently under investigation so that the expression for corrosion rate can be refined. Undoubtedly, a significant parameter, which has to date only been considered qualitatively, is the flue gas temperature and the heat flux [6]. Although steam temperature has been accurately measured as far as possible, measurements of gas temperatures have been incidental and less reliable.

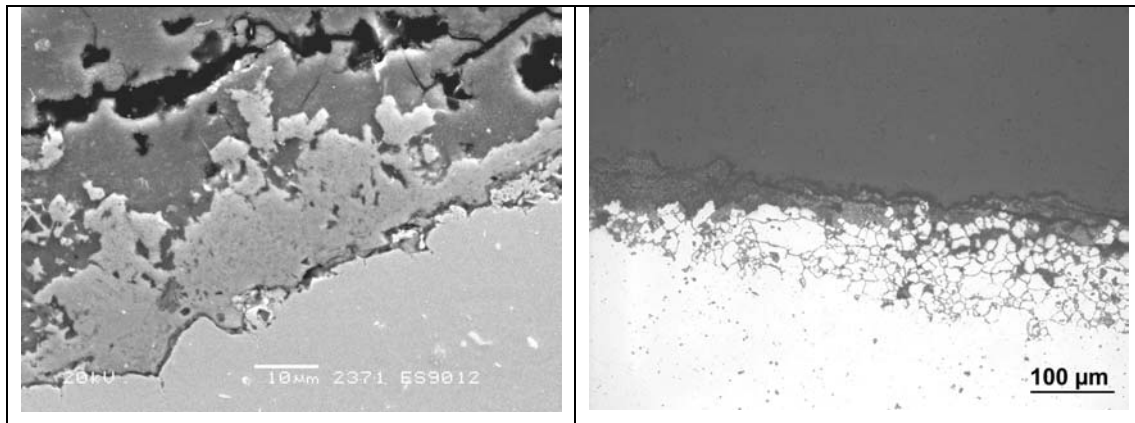
Figure 6 shows TP347HFG tubes which were exposed in the plant for 2000h. In most areas, the formation of a protective oxide was seen; however, on one specimen there were areas of grain boundary attack and non-protective oxide formation. The difference in corrosion attack is also reflected in the corrosion rates where the area with protective oxide has a corrosion rate of 0.02mm/1000h, and the grain boundary attack area was four times higher.

Figure 6: Two similar specimens of TP347H exposed for 2000h at the same time and location at Ensted woodchip boiler at a metal surface temperature of 520°C.

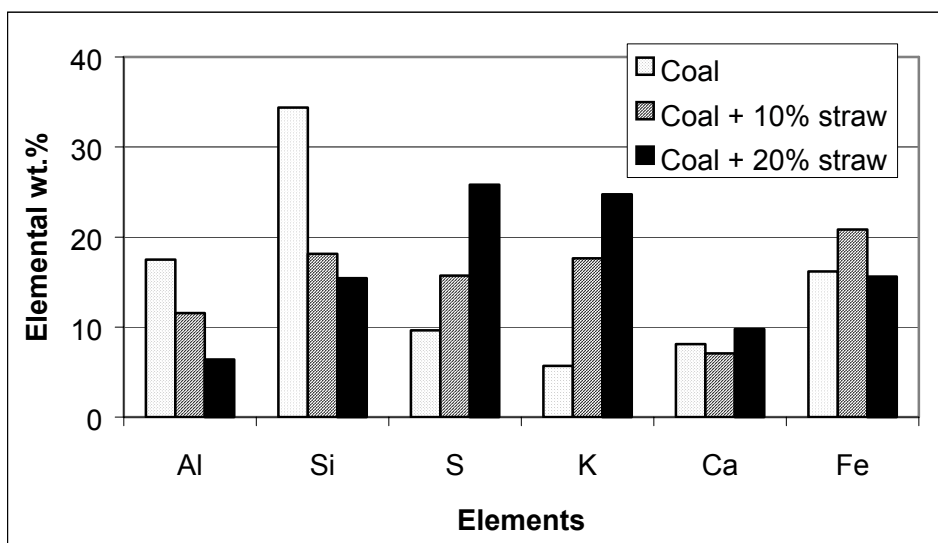
Figure 7: EDS analysis for average composition of main elements in ash adjacent to corrosion products. (Oxygen is not included in the analysis.)

The main elements detected in the ash are aluminium, silicon, sulphur, potassium, calcium and iron. Whilst aluminium and silicon decrease as the percentage of straw in fuel increases, the percentage of sulphur and potassium increases. Deposition studies support this observation [12]. No chlorine was detected in the deposits or corrosion product, or at the corrosion front. The composition of the ash showed particles rich in aluminium, silicon, potassium and oxygen (potassium aluminosilicates) in a matrix rich in potassium, sulphur and oxygen, i.e. potassium sulphate. Iron oxide precipitates were also present within this potassium sulphate matrix.

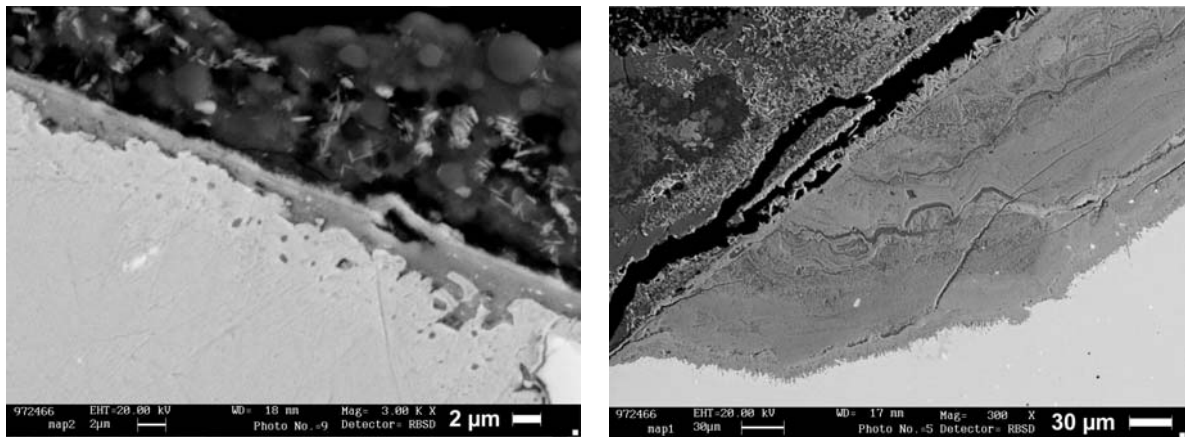
The corrosion morphology for 10% straw and 20% straw co-firing at low metal temperatures is similar to that seen in coal-firing plants, i.e. an outer layer of iron oxide, and an inner layer of iron chromium oxide. Sulphur in the form of sulphates or sulphides are present within the oxide. With 20% straw co-firing at high temperatures (approx. 580°C), as well as the corrosion morphology described above, large shallow oxide pits are present, especially for the austenitic steels. Figure 8 shows a thin and thick oxide on the same specimen of a HR3C steel (niobium modified 310 stainless steel). The thin oxide is similar to that seen with 10% co-firing for this high alloyed steel. In the base regions of the oxide pit, sulphates or sulphides are detected.

FIGURE 8 - Two different areas on the niobium modified 310 steel specimen with a metal temperature of 586°C exposed at Studstrup to 20% straw co-firing.

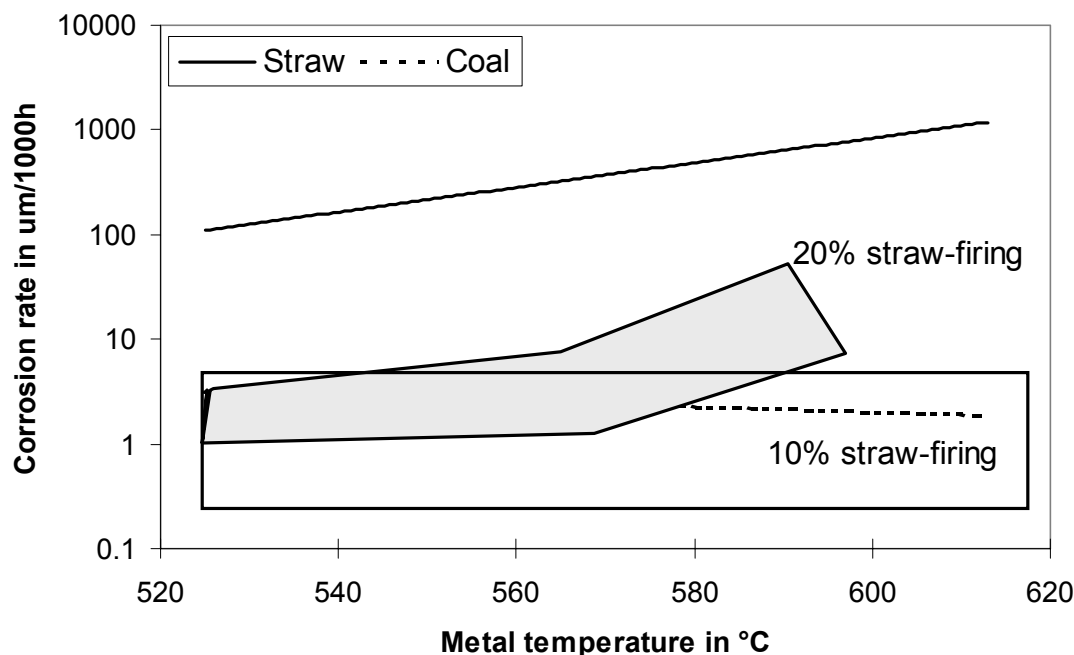
Figure 9: Comparison of TP347H corrosion rates in co-firing of straw and coal compared to 100% coal-firing and 100% straw-firing.

Corrosion rates in straw co-firing lie in the same region as those for coal-firing and significantly below the results for straw-firing. For specimens with 10% straw co-firing, corrosion rates can be considered as similar to coal-firing in all temperature ranges, even those where there is an increased metal temperature. For 20% straw co-firing at low temperatures, the corrosion rate is also similar to coal-firing. There is an increase in the corrosion rate at high temperatures due to the change in corrosion mechanism as iron sulphate-potassium sulphate melt is formed.
