Metallurgiske undersøgelser af rulle-lejer

DMS Vintermøde, Viborg, Januar 2016

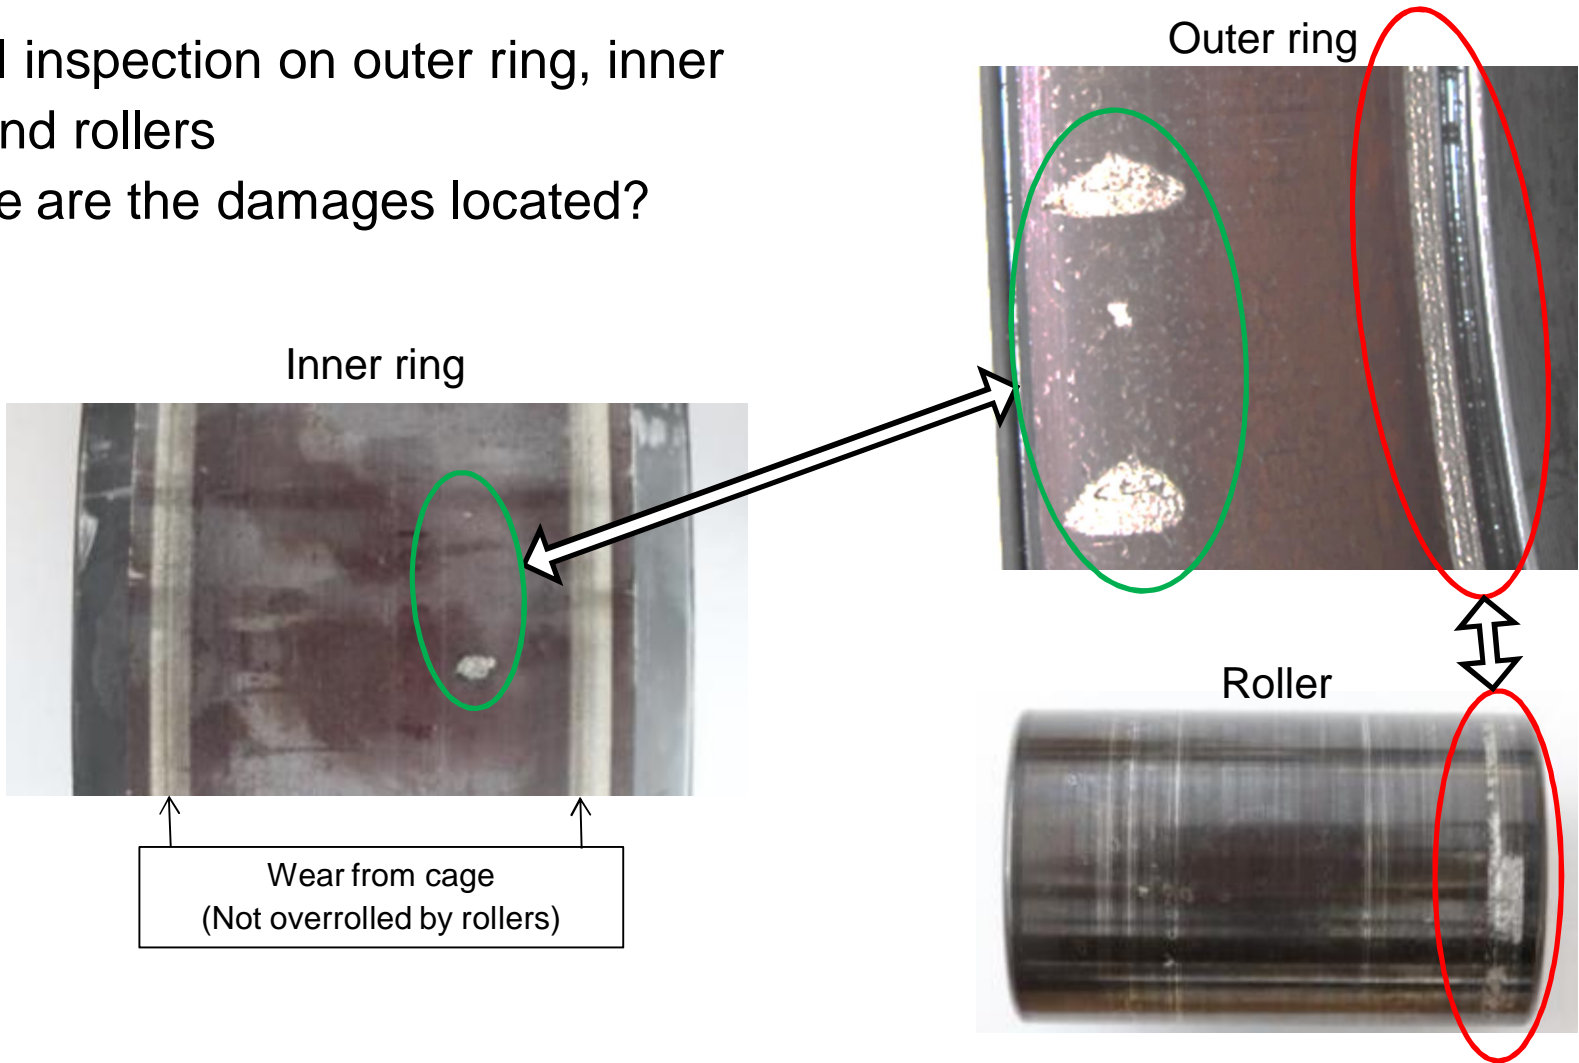
Example 1 – Visual inspection

Visual inspection on outer ring, inner ring and rollers
 Where are the damages located?

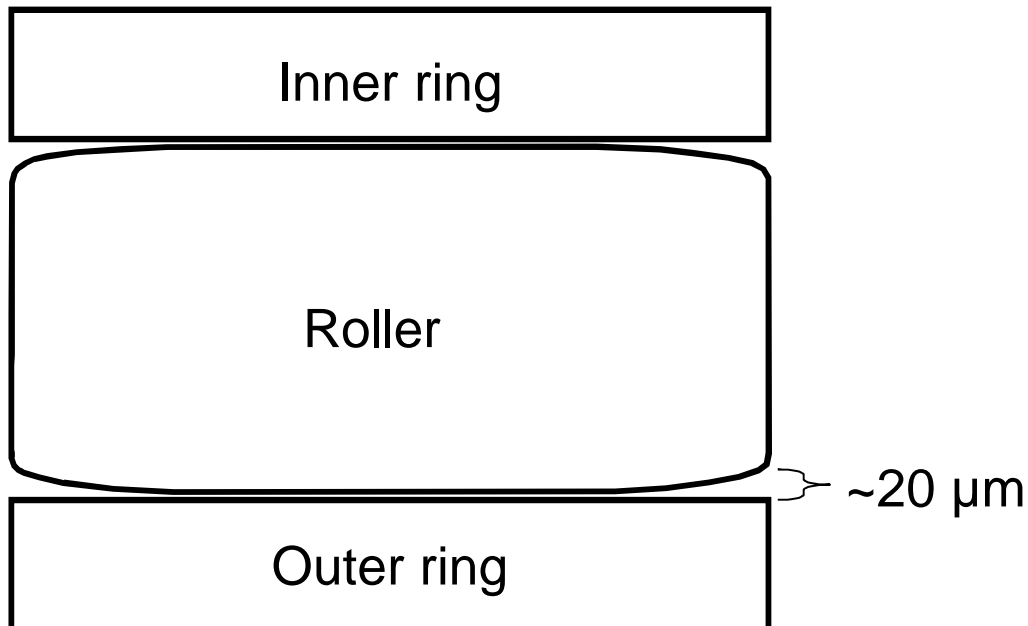
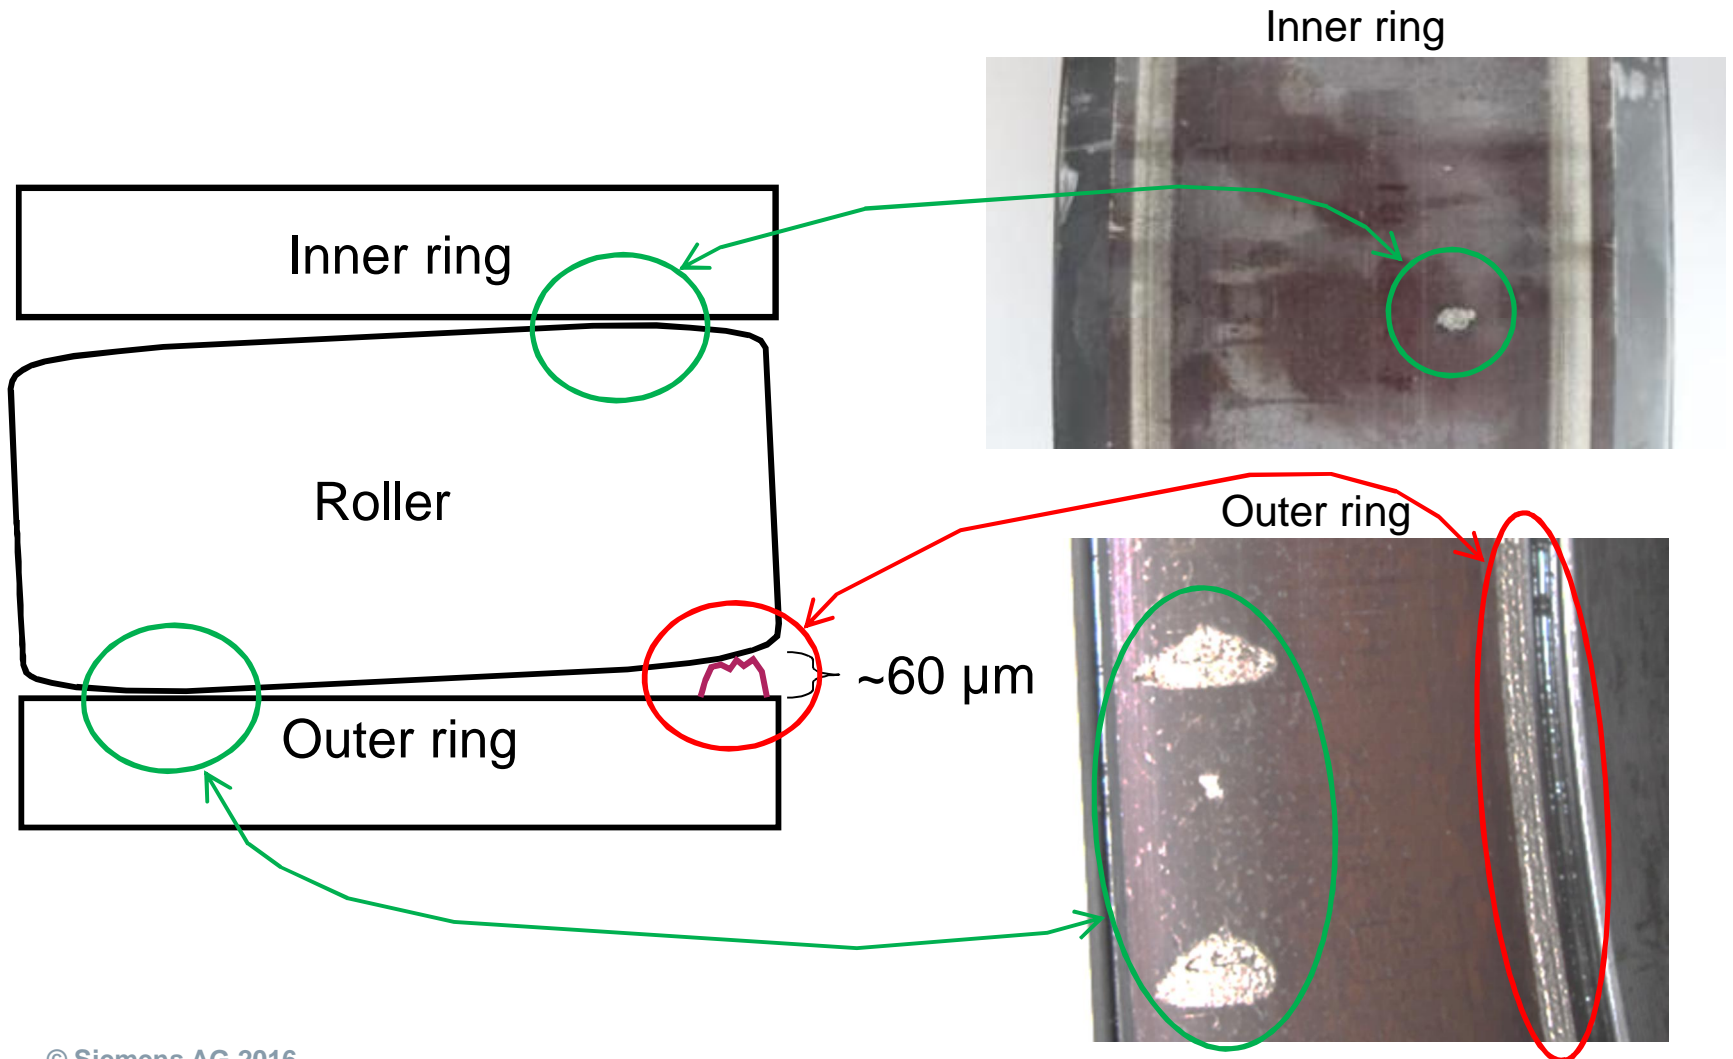
Example 1 – Influence of roller profile (crown rollers)

In order to avoid high stress peak at edge of rollers, profiling are used on rollers

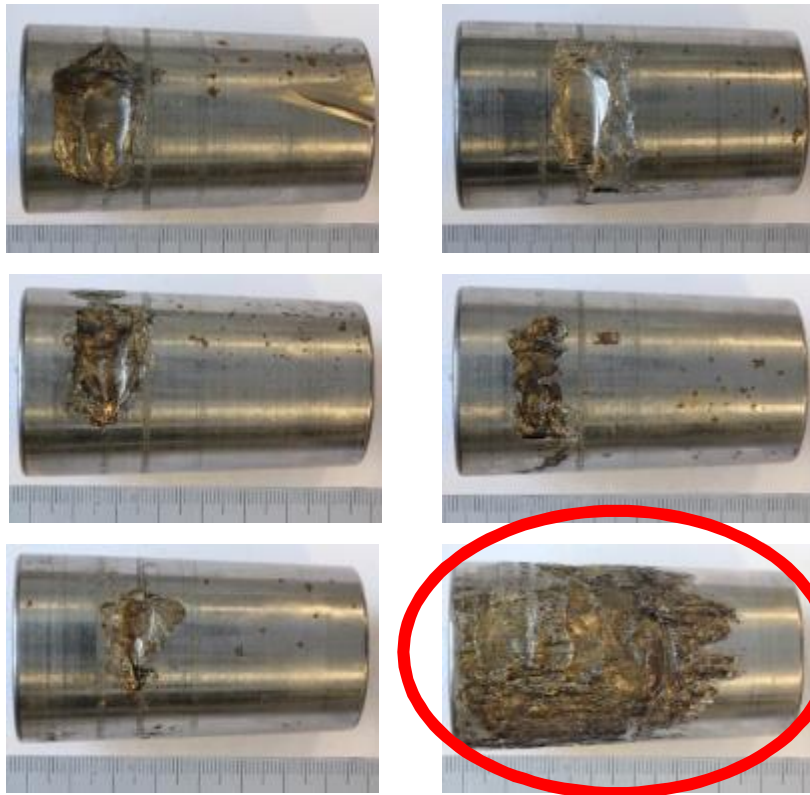
Rollers

For most cases:
Bearing failure starts on inner ring

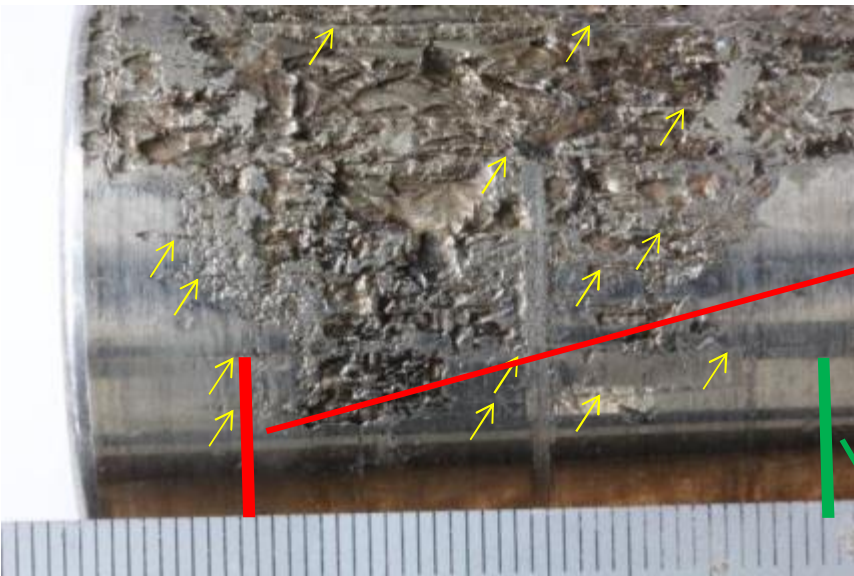
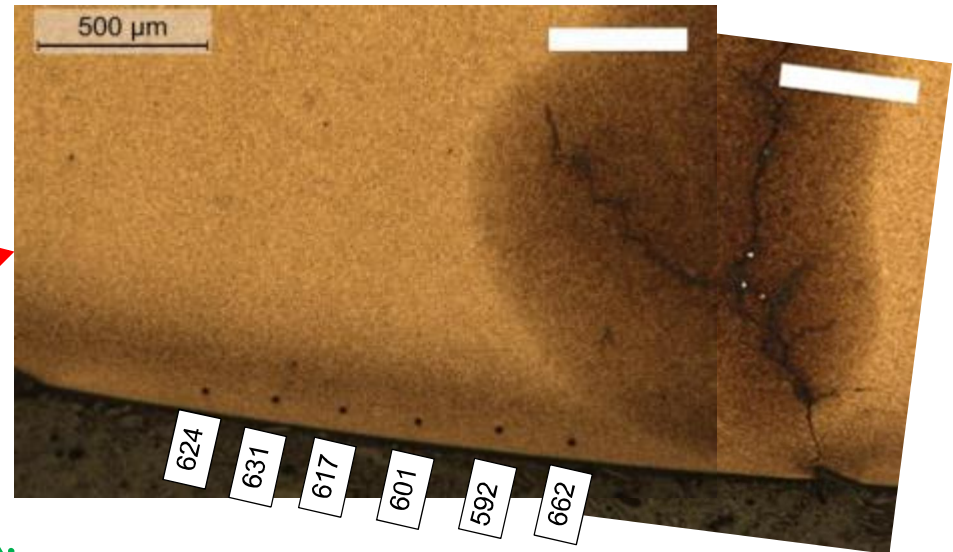
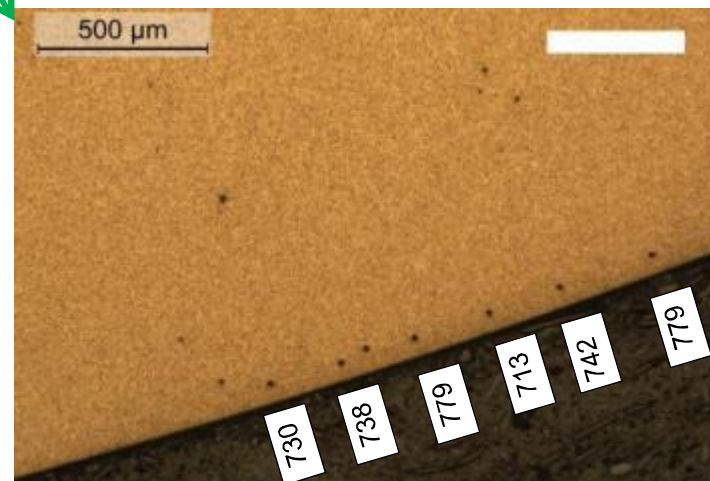
Example 2 – Cross section of roller

Axial cracks on roller
 Cross section – Nital etched
 Hardness measurement
 Grinding burns (grinding tempering)

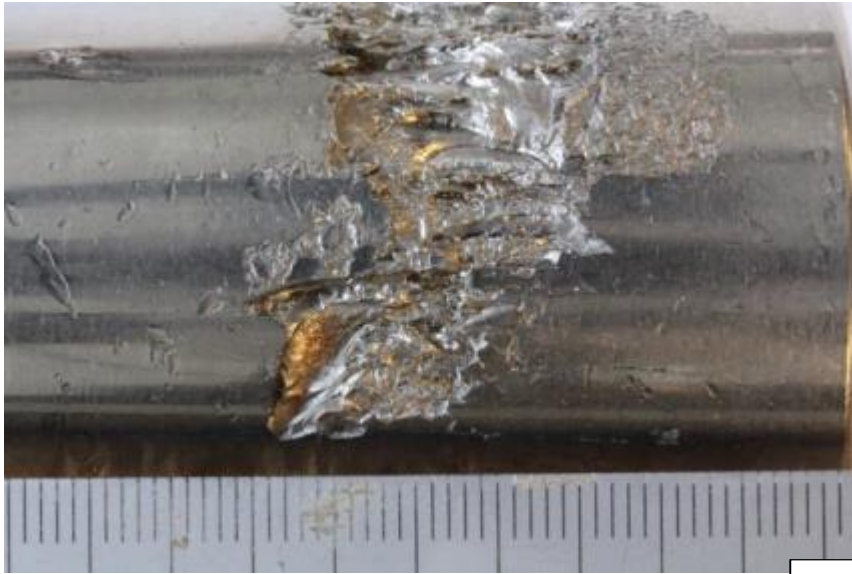
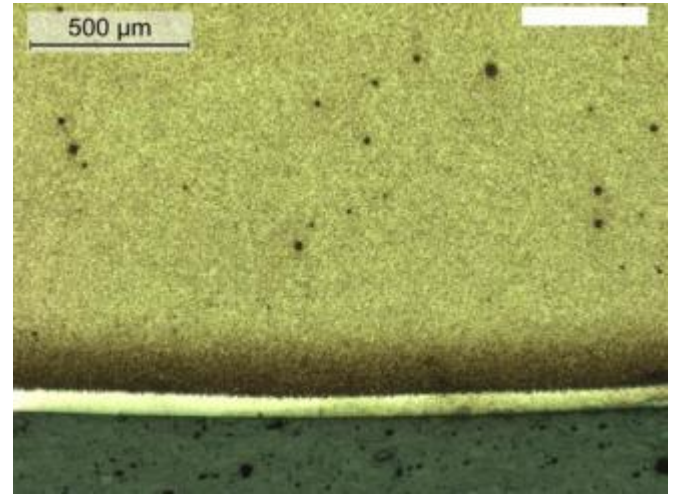
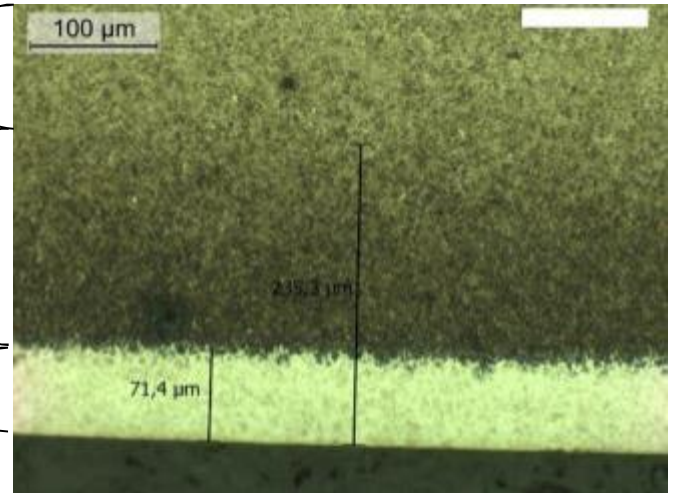
Example 3 – More severe grinding burns

Axial cracks on roller
 Cross section – Nital etched
 Grinding burns (grinding tempering)

Not affected

Tempered at high temperature

Untempered martensite

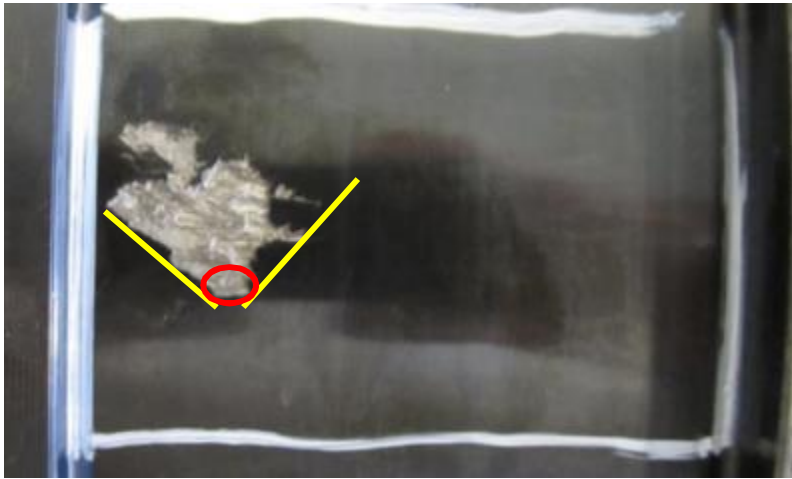
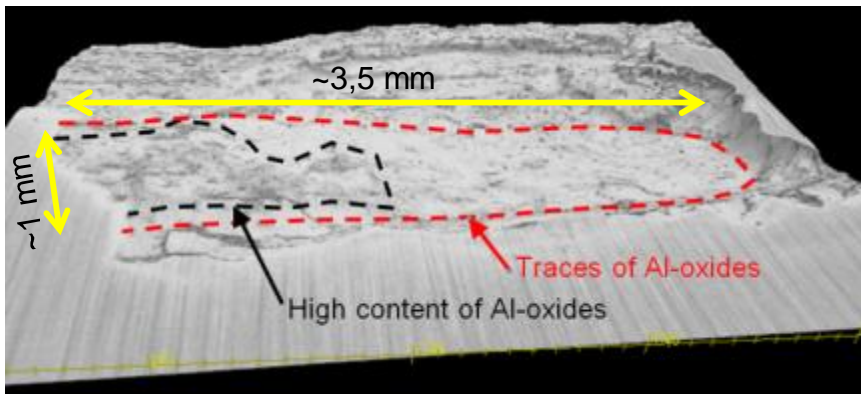
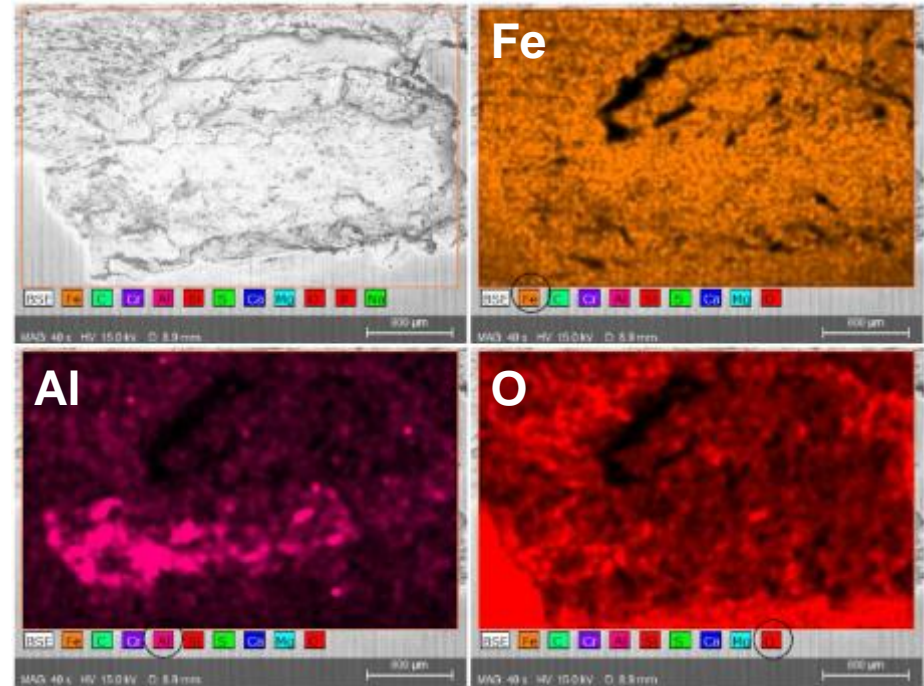
Example 4 – Macro inclusions

Spalling on bearing
 V-shape indicates starting point
 Al and O (Al-oxide) present at starting point

Element mapping by EDS

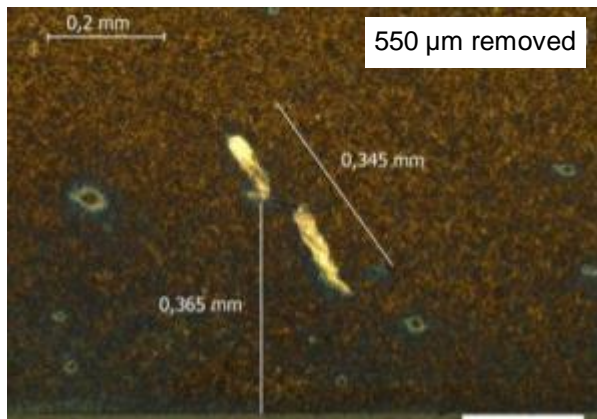
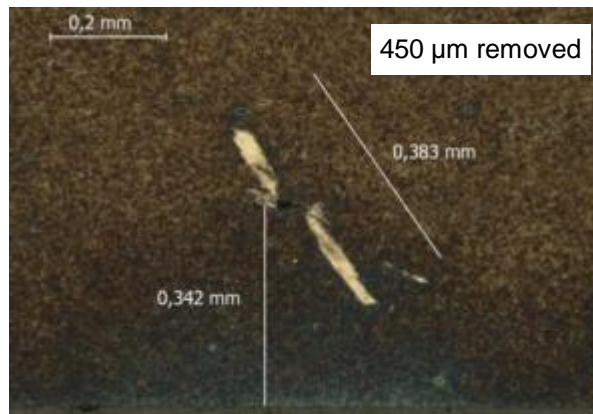
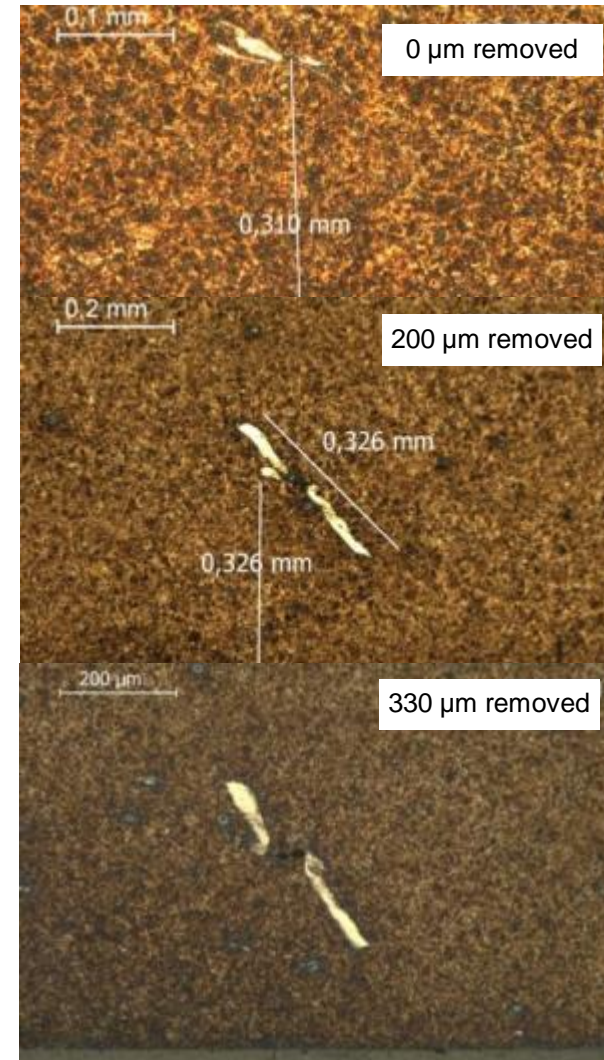
Example 6 – Butterflies at micro inclusions

- Circumferential cross section
- Raceway downwards
- Sample re-grounded several times
- Axial length of inclusion >550 μm

For long inclusions, butterflies can grow to a critical size

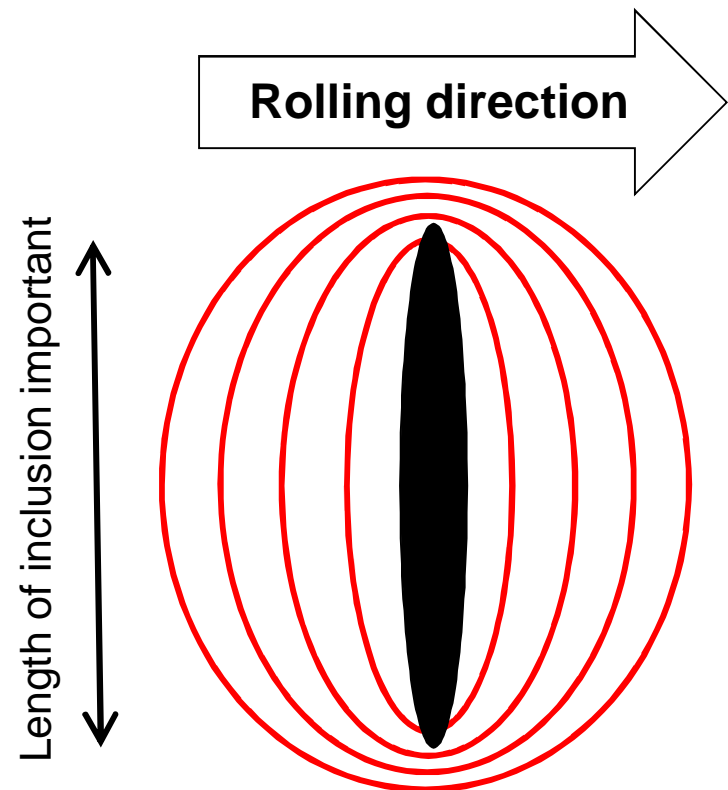
Example 6 – Growth of butterflies at inclusions

- Initiates on front and back side of inclusion in relation to rolling direction
- Mechanism probably differs from normal fatigue crack growth (inclusion too small to initiated growth of fatigue crack)
- Growth of butterflies appear to slow down or stop at certain distance from inclusion
- Unless inclusion is too large. Then it continues to grow.....

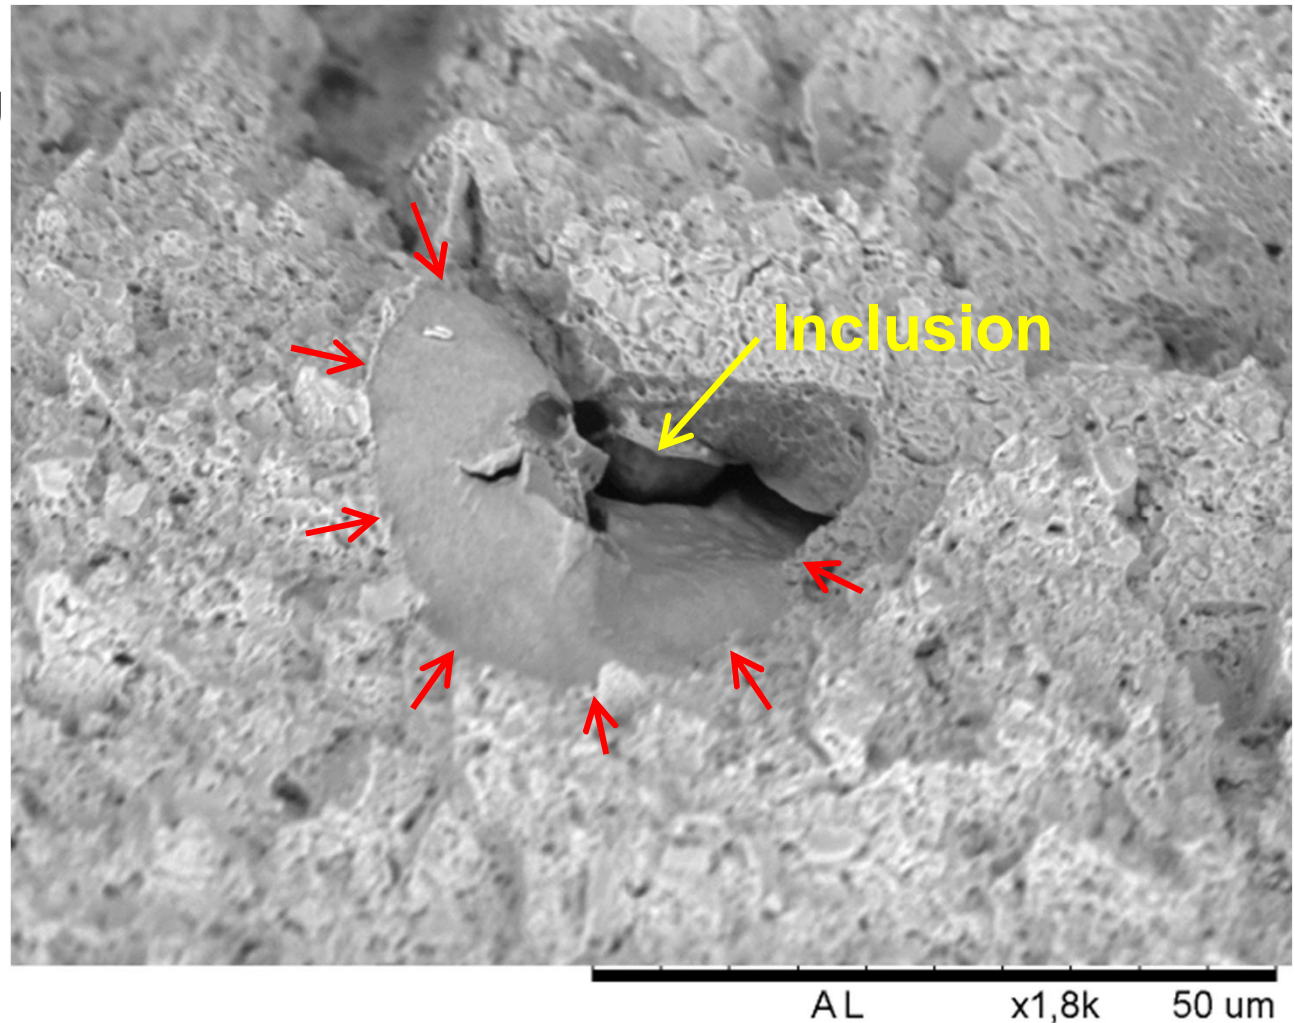
Example 6 – Growth of butterflies at inclusions

Self made fracture
on bearing revealing
part of butterfly at
inclusion

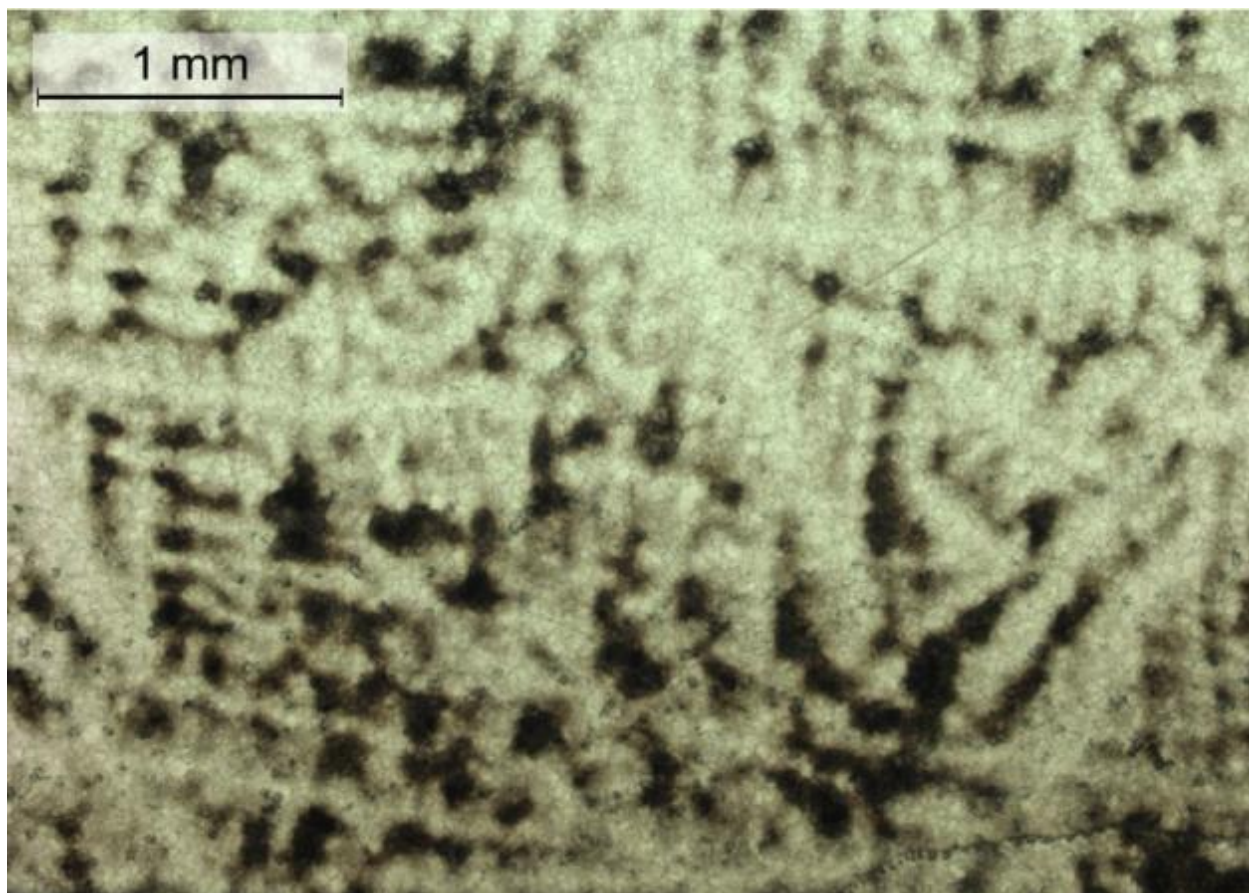
Challenges for industry: Scale of size

Dendritic structure visible in final part

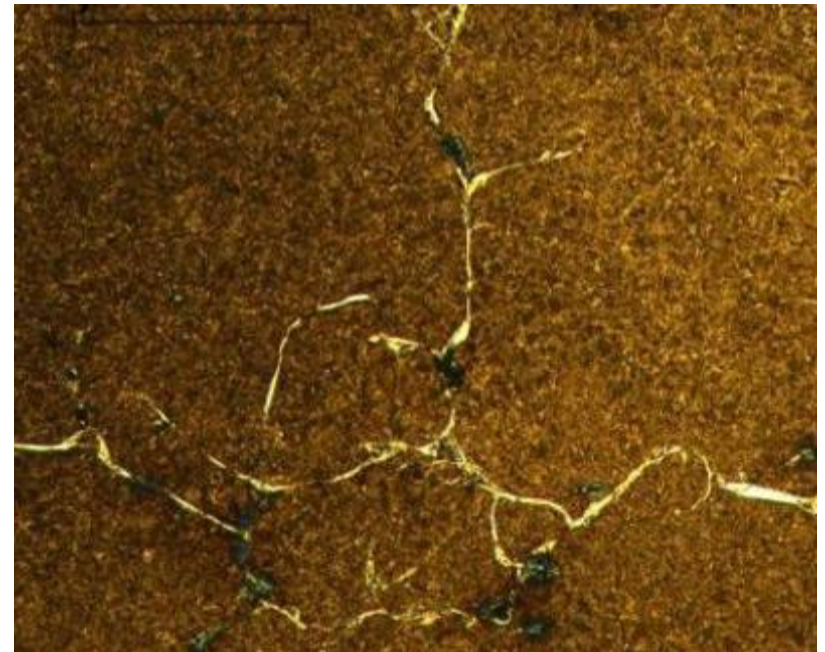
Challenges for industry: IRWEC

- Irregular White Etching Cracks, also known as:
 - IRWEC, WEC, WEA, white flaking, axial cracks, white matters etc.
- Premature failure of bearing
 - 1 to 20% of calculated bearing life
- Associated with irregular subsurface cracks with “white etching area (WEA)”
- No common understanding of root cause
 - Many different root causes had been discussed and more will probably pop up
- No known calculation method present
- Known in many industries:
 - Wind turbine, automotive, washing machine, paper mills, coal pulverizer, crane lifting unit, etc.
