White Etching Cracks i lejer til vindmøller

DMS Vintermøde 2016: Udfordringer i metallurgi

Hilmar Danielsen

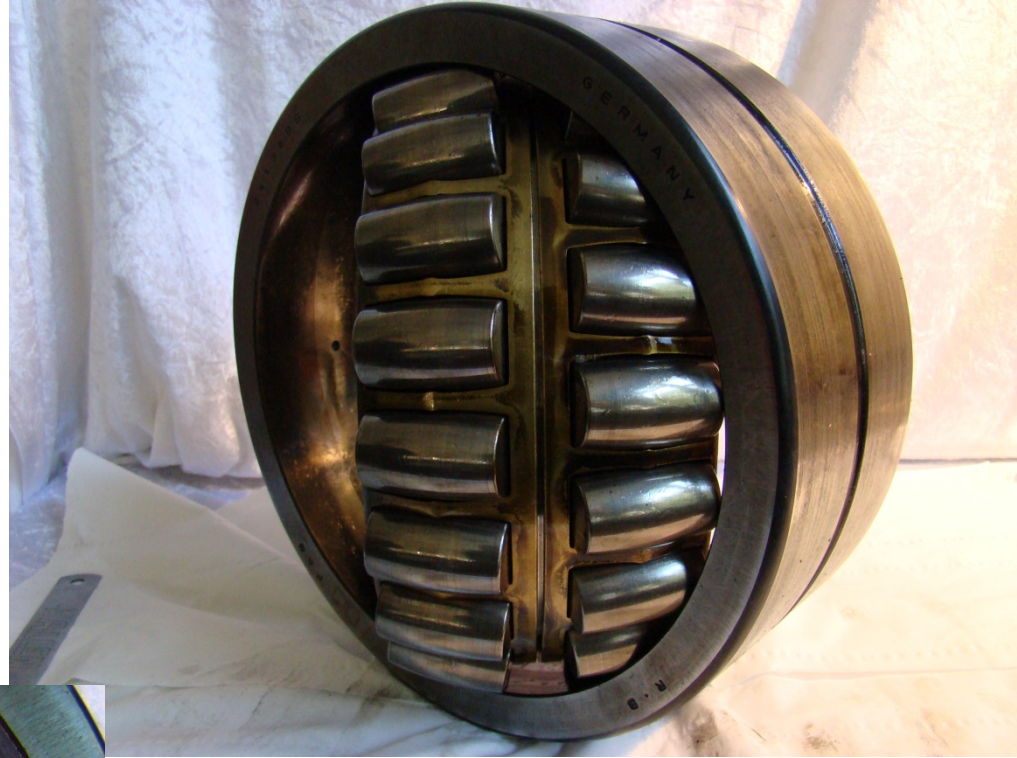
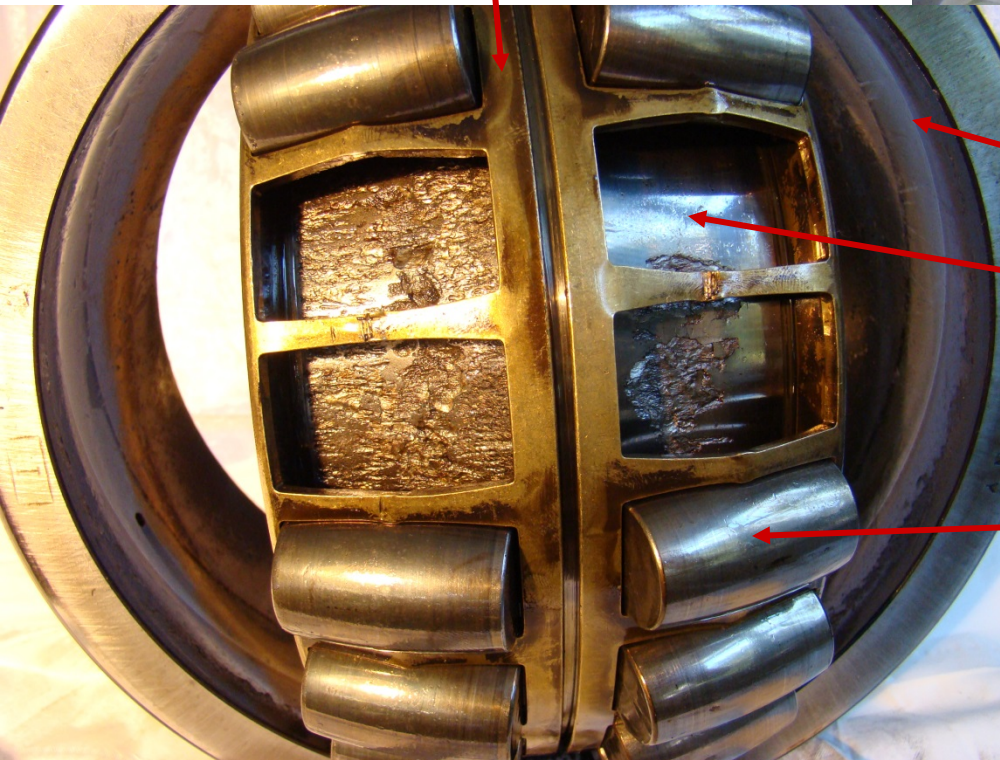
Gearbox bearing

Brook-Hansen gear
660kW Vestas windmill type V47
After for 10 years service

Outer ring

Inner ring

Roller

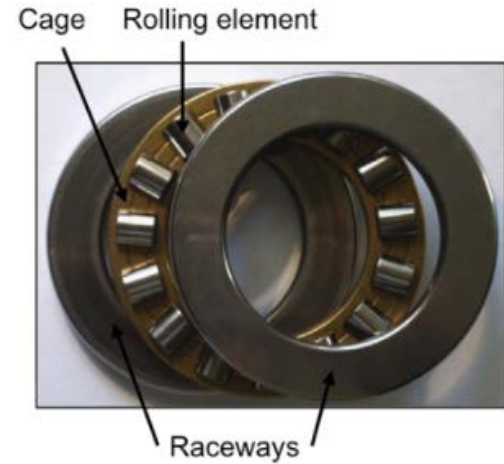
Bearing test facility

Accelerated WEC can only be done on axial cylinder roller bearings

Axial cylinder roller bearings

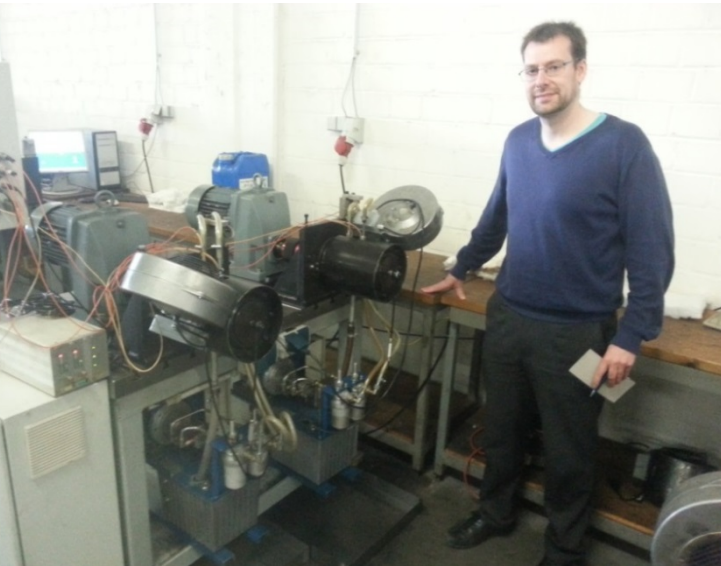
Double-headed test rig:

- Can reproduce WEC
- Dynamic loading and speed
- Oil and grease lubrication
- Temperature control
- Different bearing configurations
- Different material/surface treatment
- Stray currents

- Only axial loads
- Slip not variable

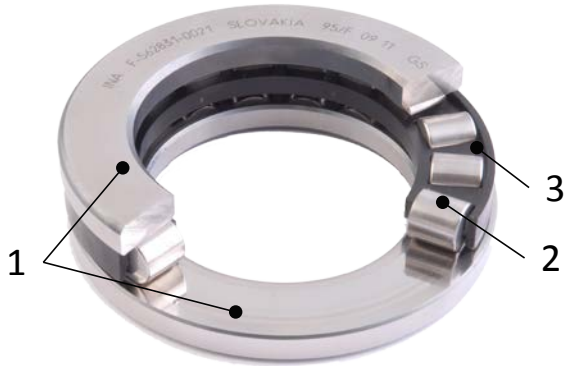
1. Bearing washers
2. Rolling element
3. Polyamid cage

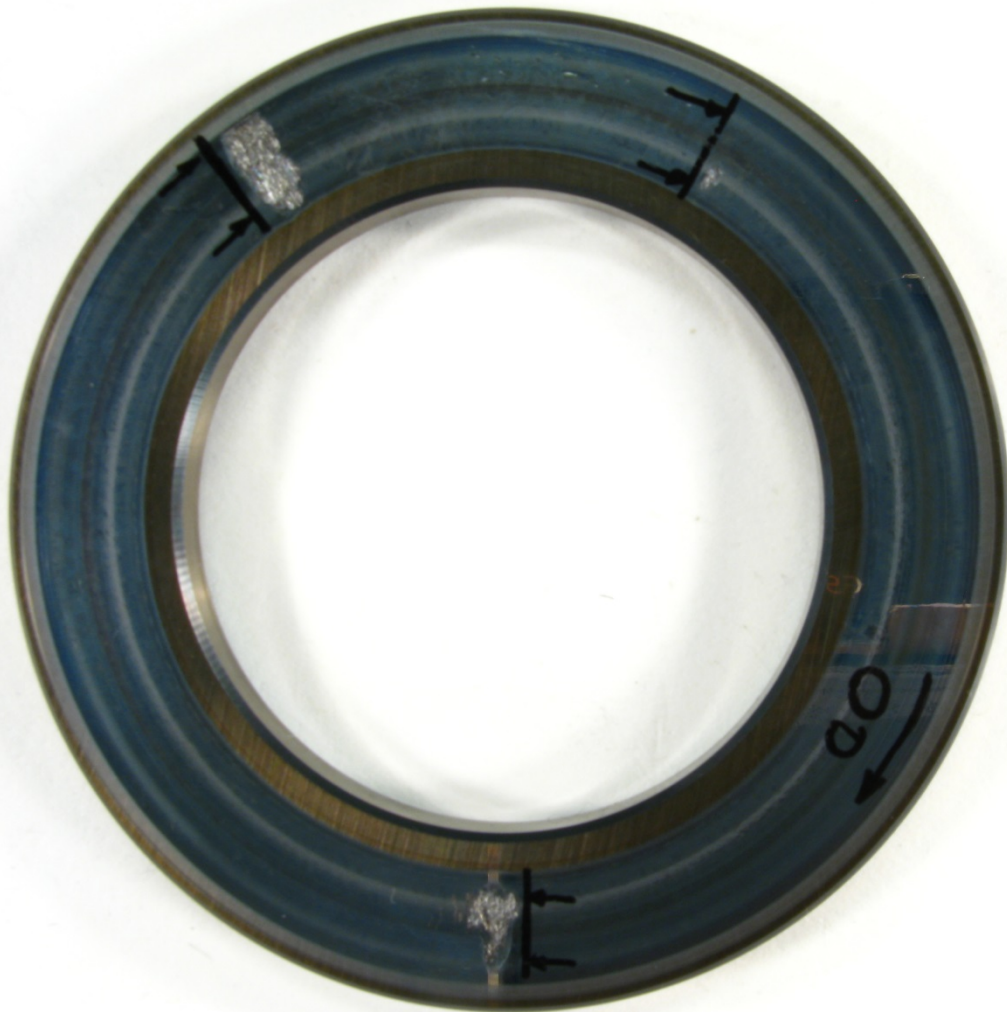
Bearing rings received
from RWTH Aachen

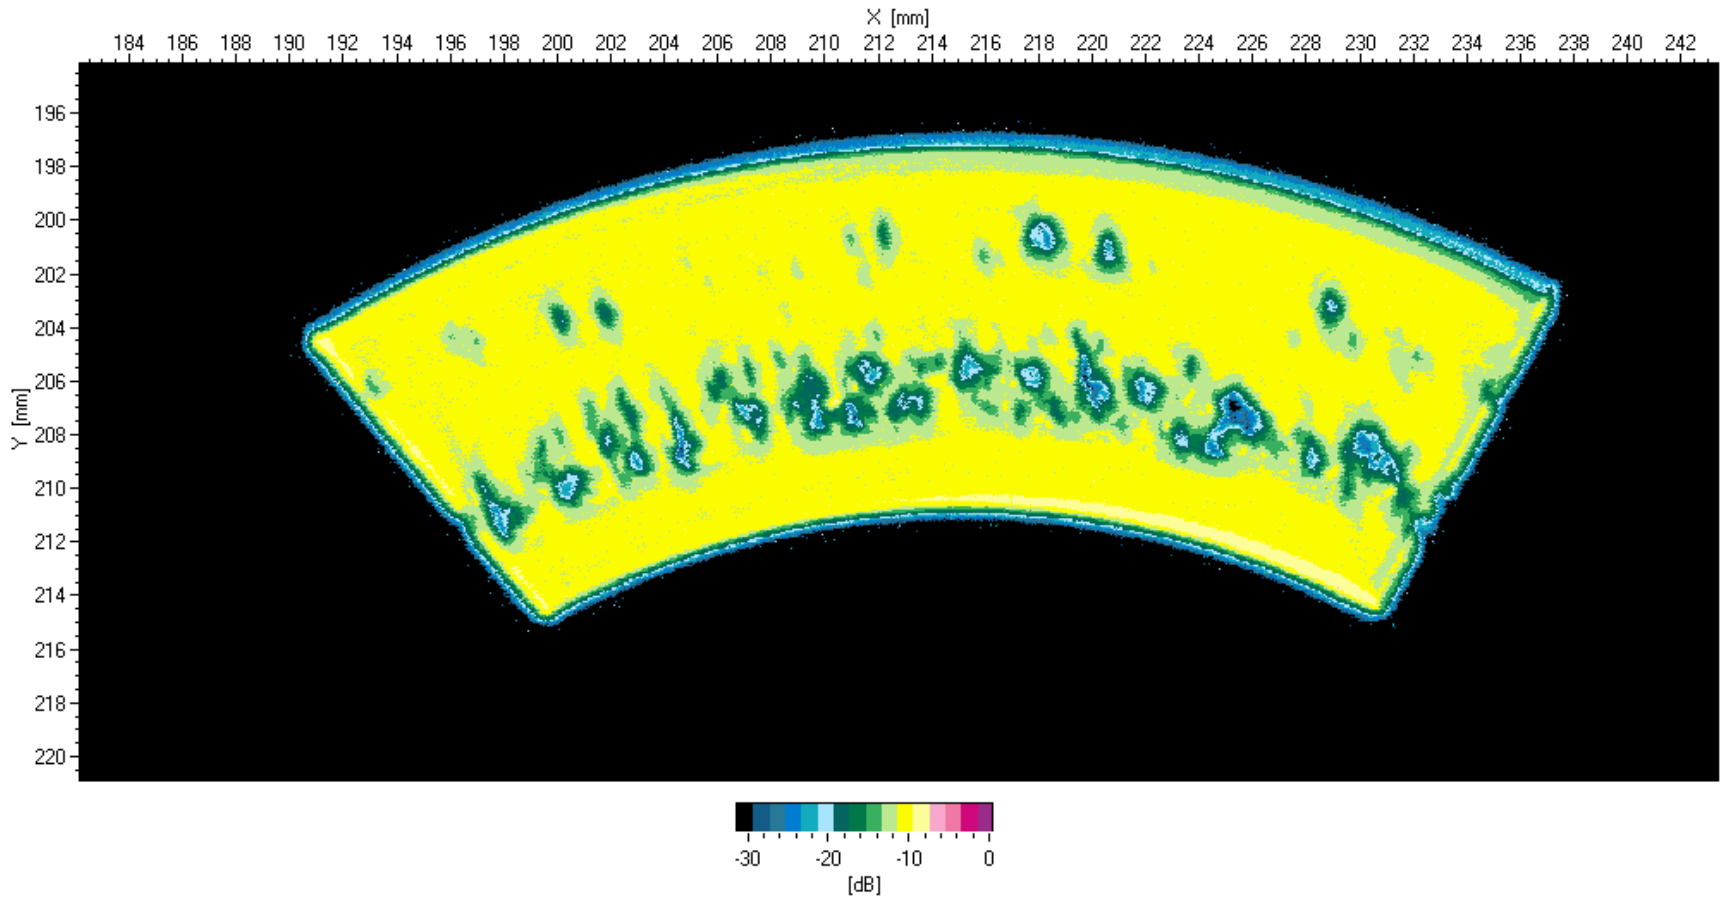
Ultrasonic testing

Part of raceway with WEC

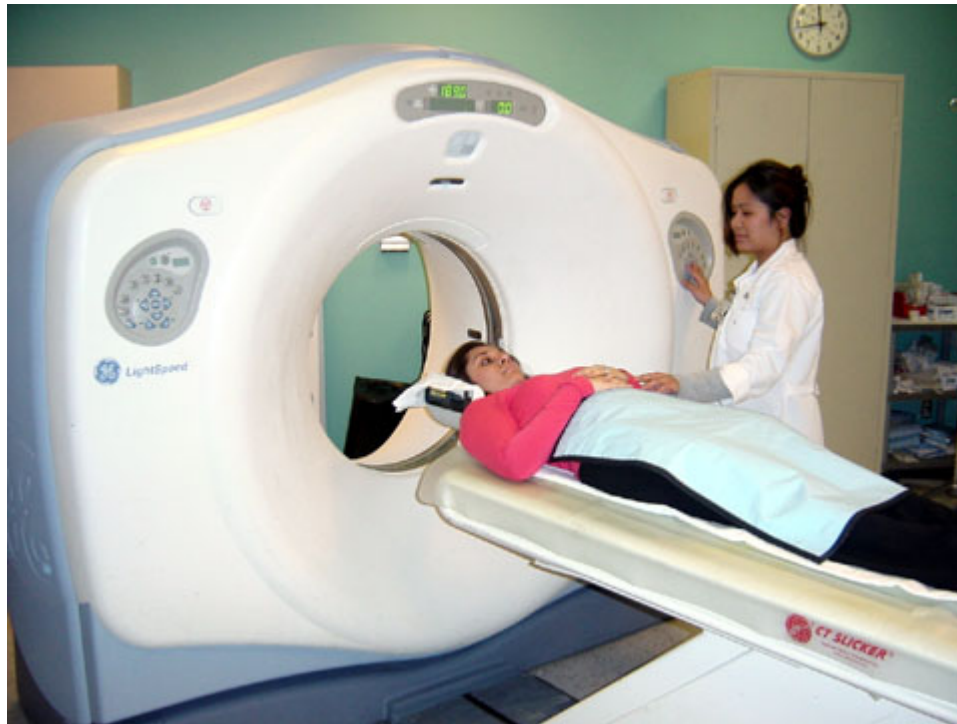
characterisation method: X-ray Computerised Tomography

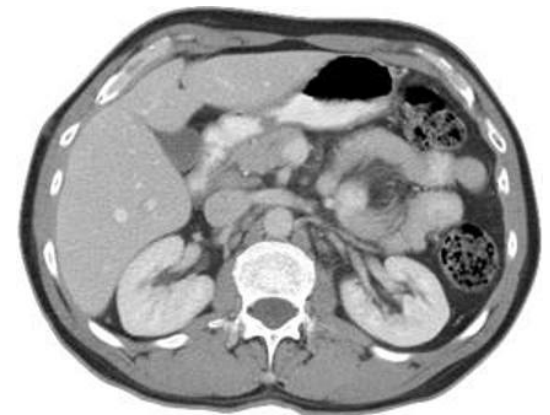
CT scanner

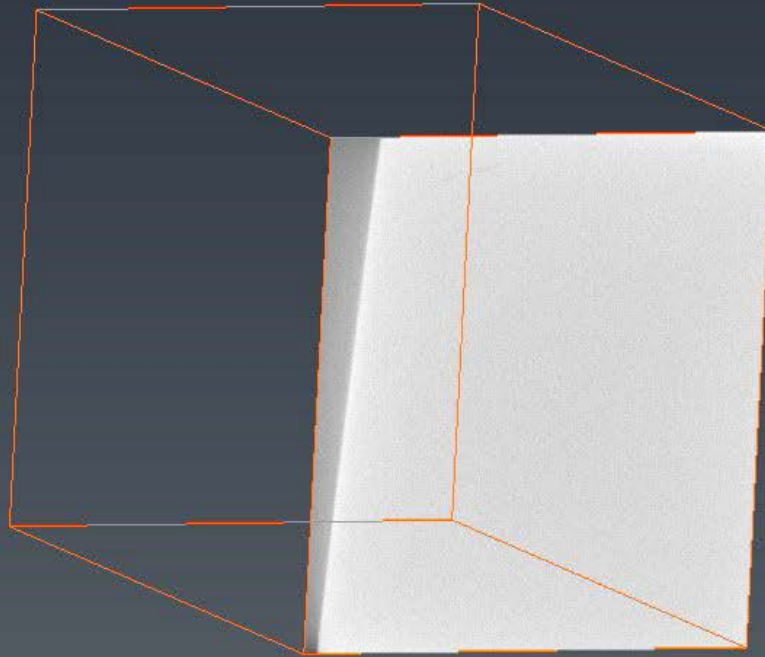
Charaterisation of bearings: Tomography

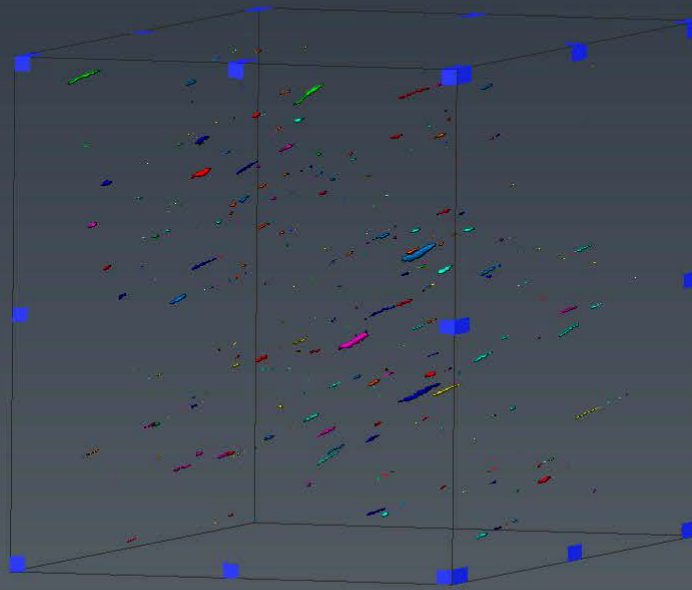
Inclusions in 1x1x1,5mm volume

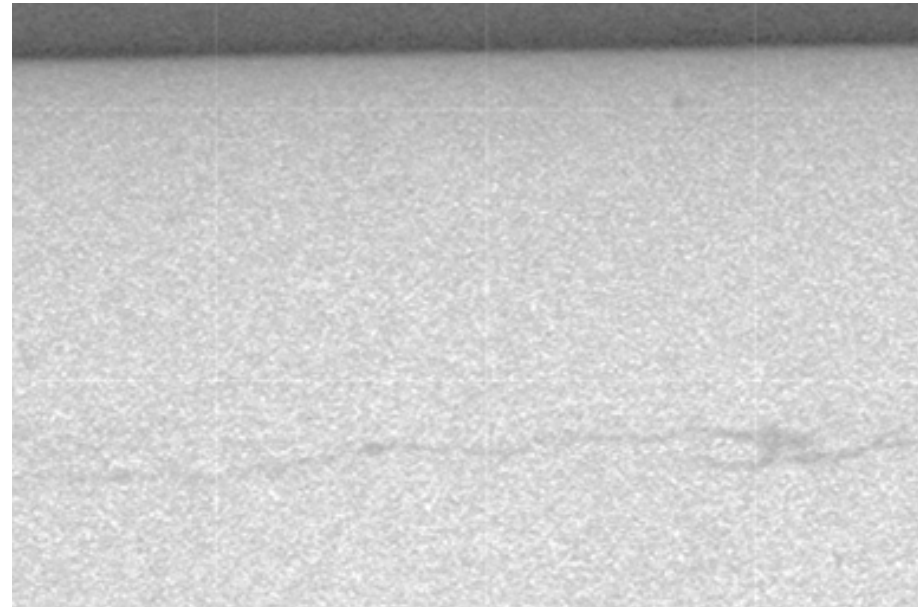
Optical microscopy

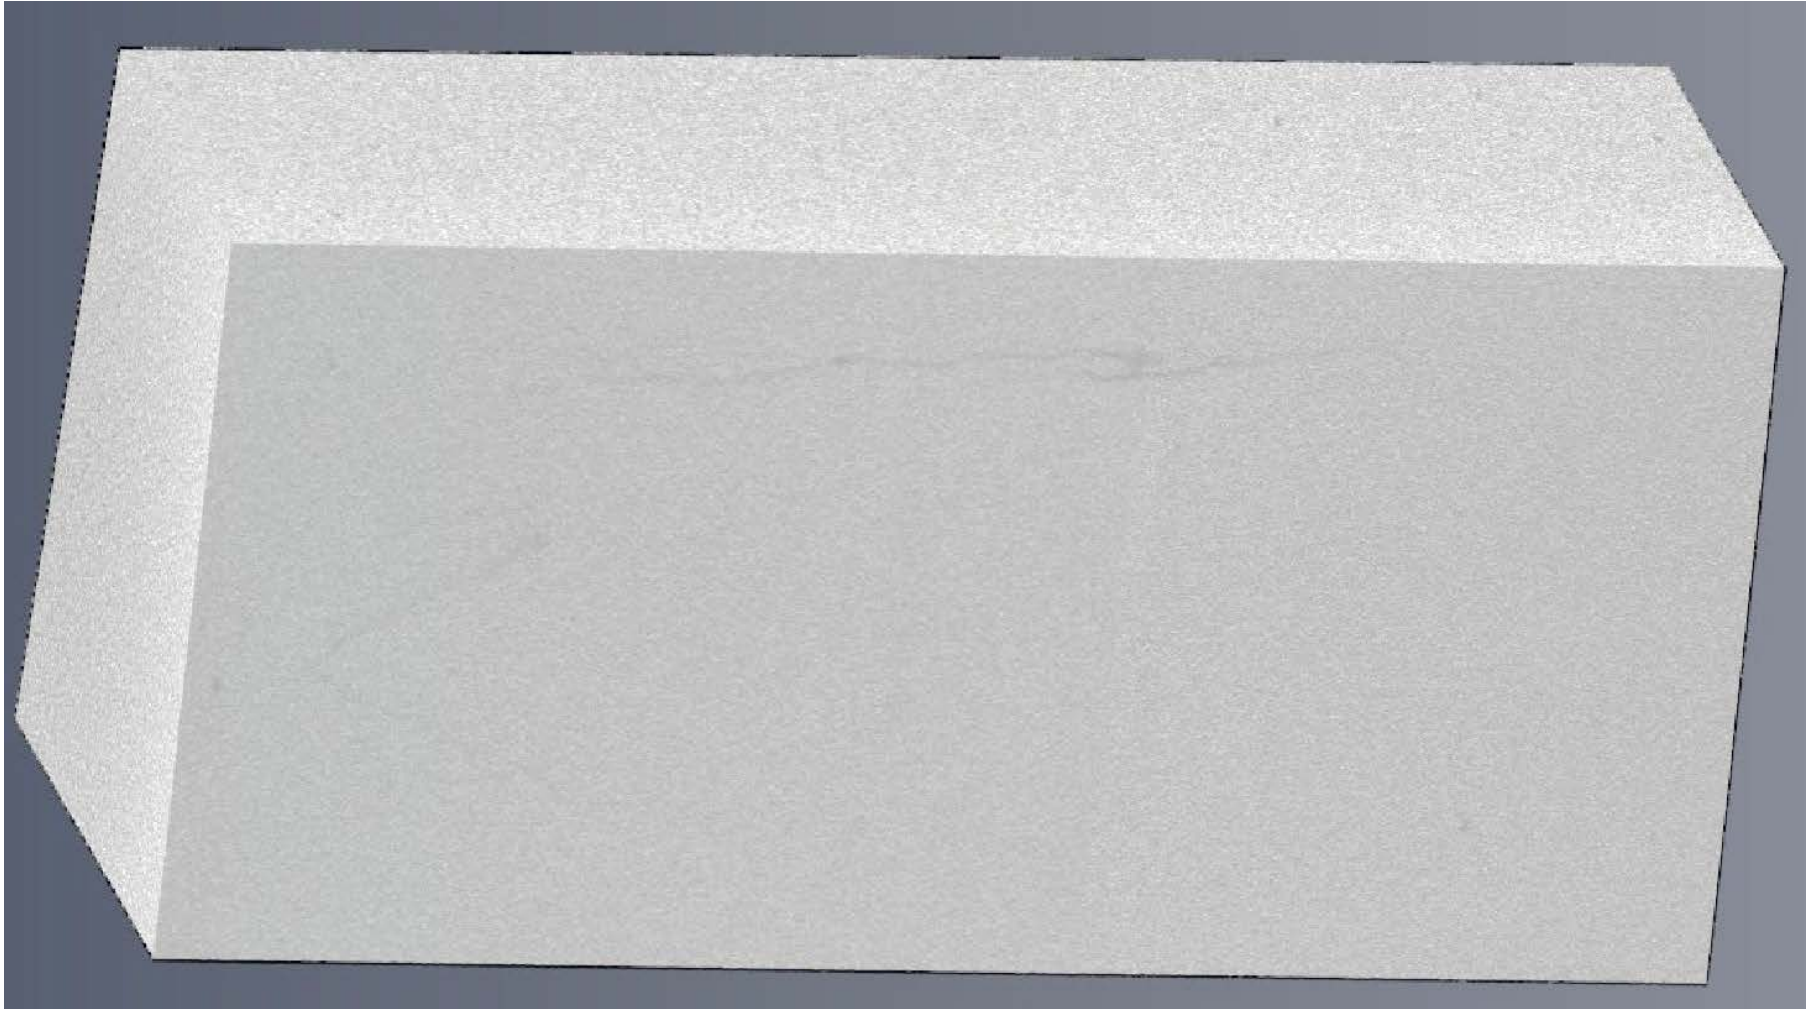
X-ray tomography

3D X-ray tomography volume

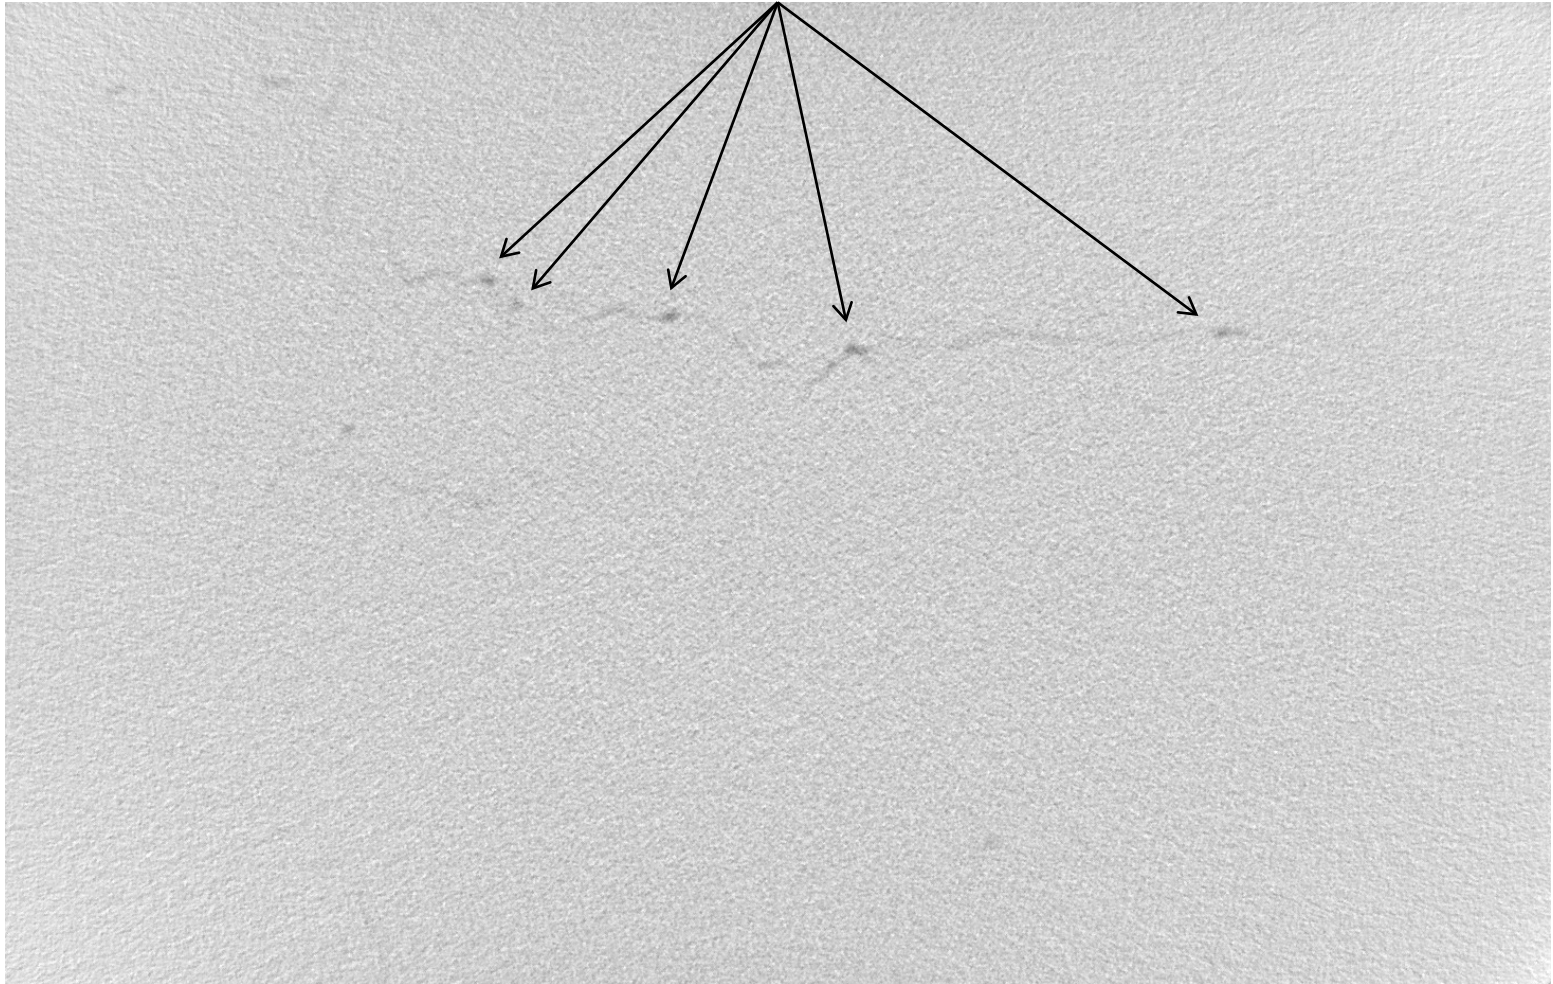
Inclusions in cracks

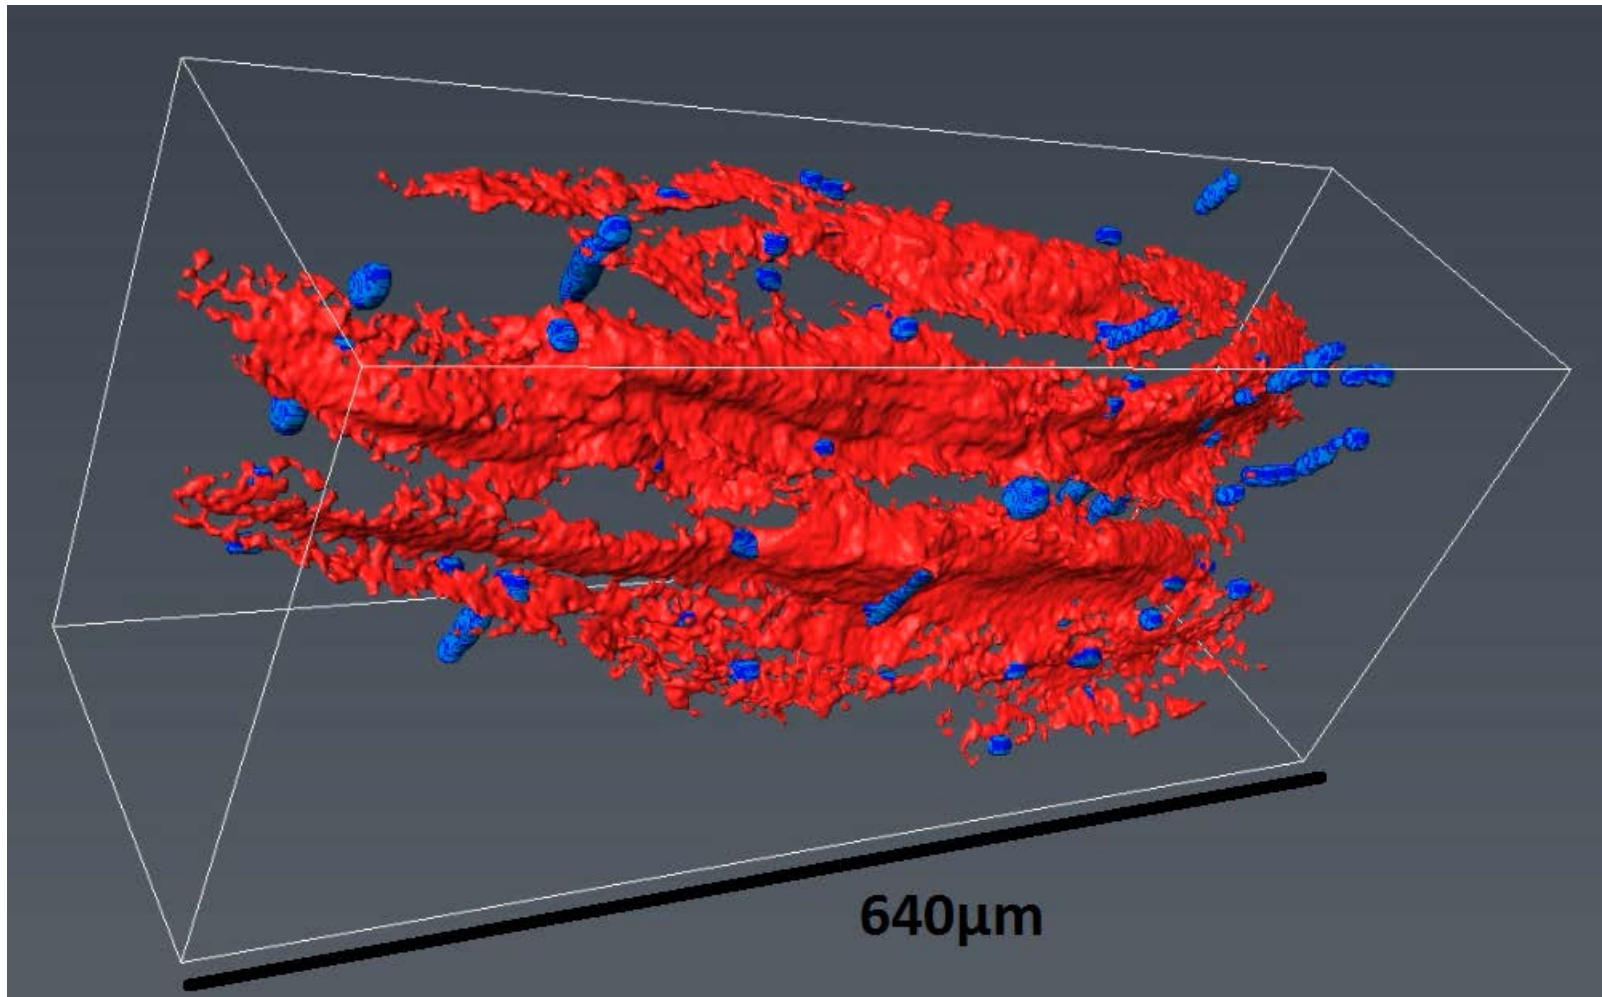
Imaging WEC in 3d
