Metallurgiske undersøgelser af rulle-lejer

DMS Vintermøde, Viborg, Januar 2016

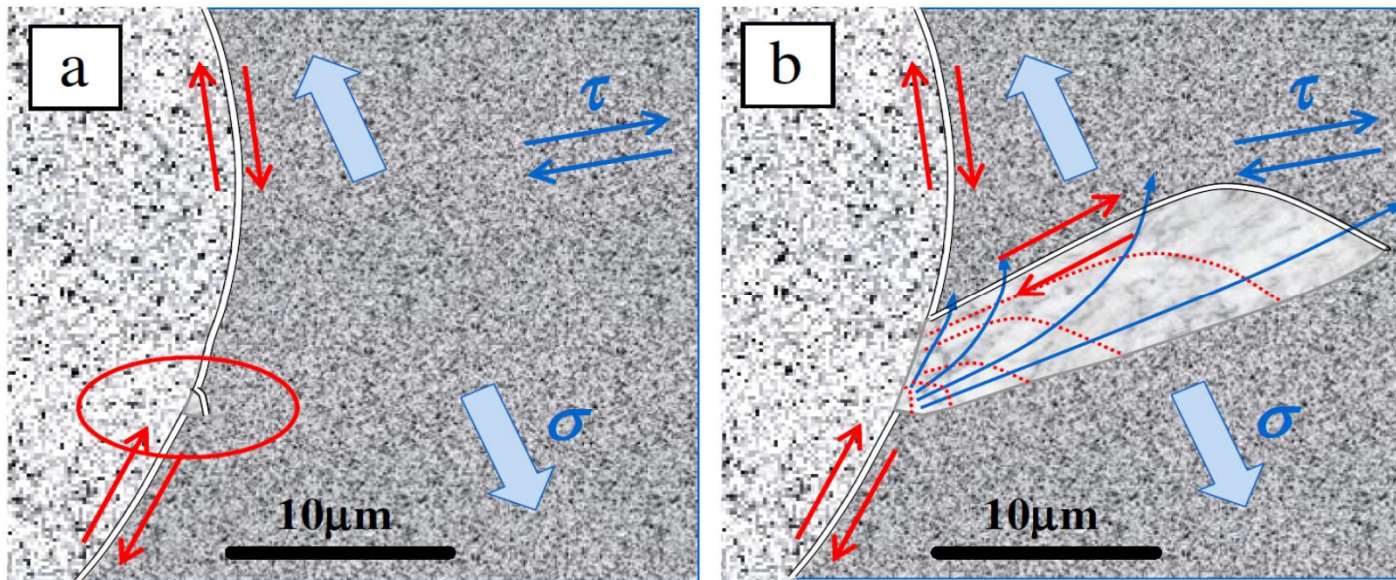
Example 6 – Growth of Butterflies

- Rubbing of interface between inclusion and steel matrix
- Transfer of material from steel matrix to surface of inclusion
- Recrystallization of deposited material into nanosized ferritic grains
- Crack growth by repeated depositing material across crack interface

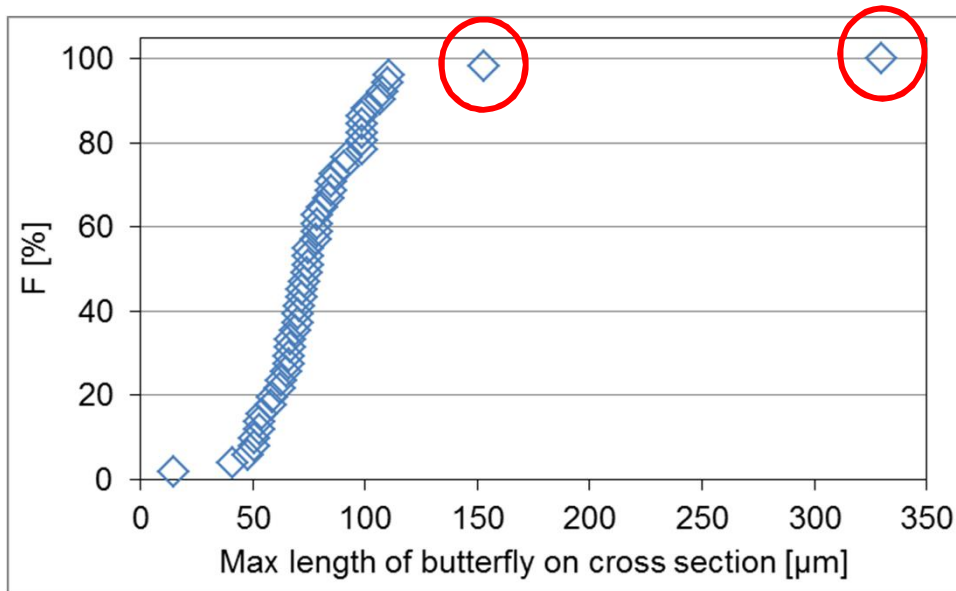
Example 6 – Length of butterflies

General observation on for butterflies:

- Present in most used bearings
- Total butterfly length typically $<120 \mu\text{m}$

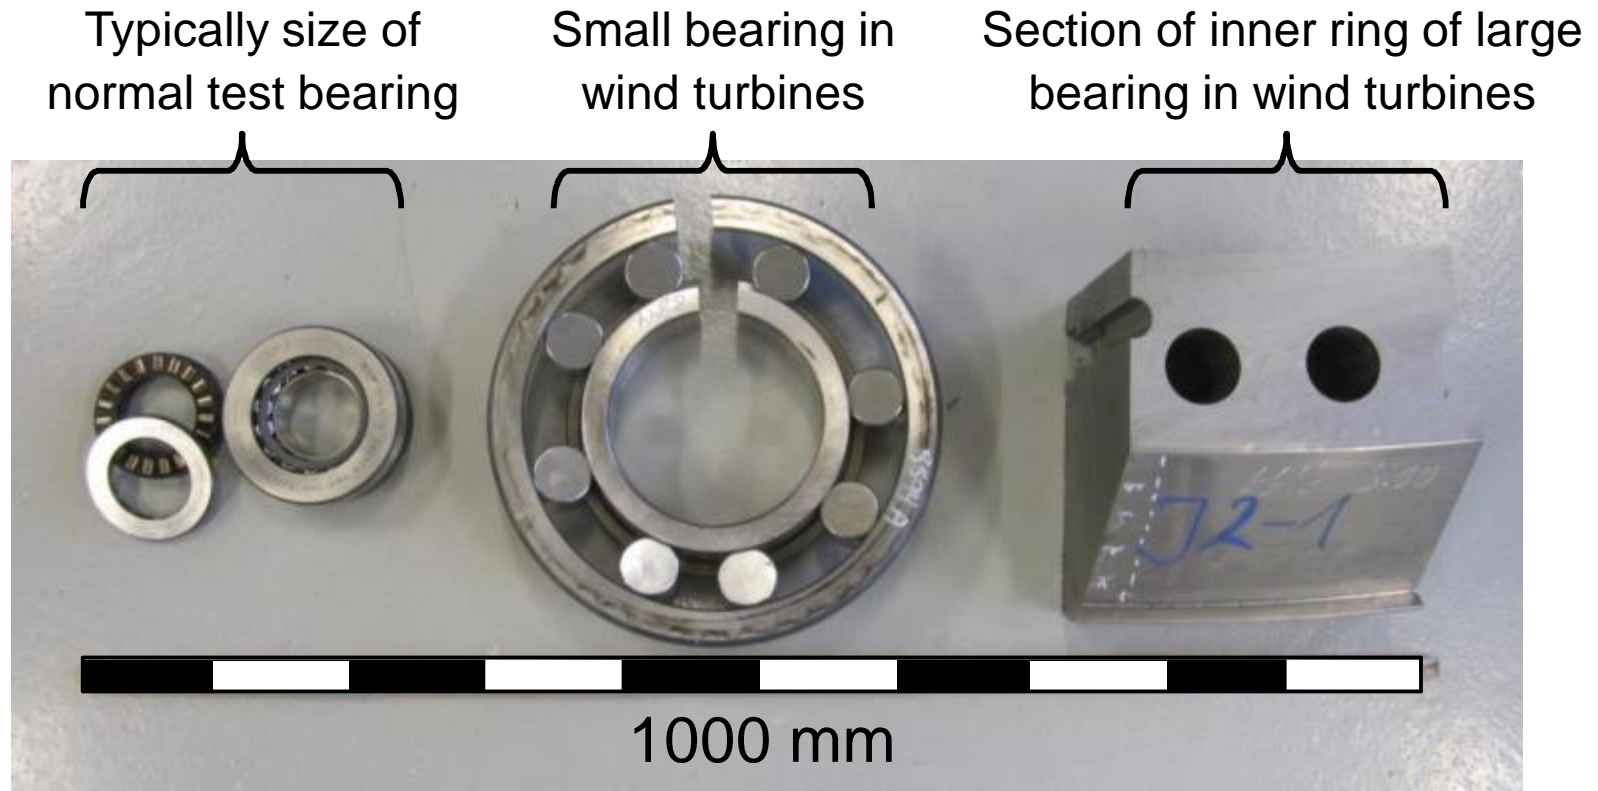
Challenges for industry: Scale of size

- Influence of casting of raw material (Solidification time -> segregation)
- Influence of forging ratio (homogeneity, grain size)
